# Access Compliance Report

## Public Rights-of-Way

### (Curb Ramps)

Intersection ID: 44913		Main Street: SPRINGHAVEN_DR		Cross Street: OAK_DR		Location: NE			
ADA ID: FA07730B7675		Ramp Type: PerpDiag		Initial Pass/Fail: Fail		Overall Compliance: No		Severity Score: 10	
Codes/Mitigation Info/Possible Solution				Field Measurements/Component Compliance

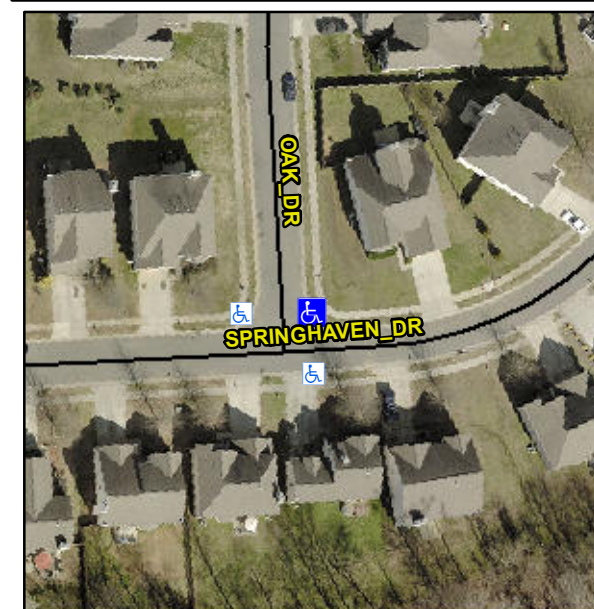
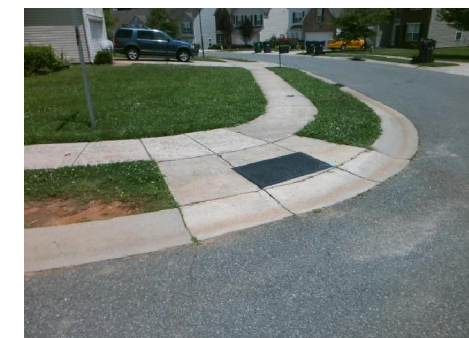
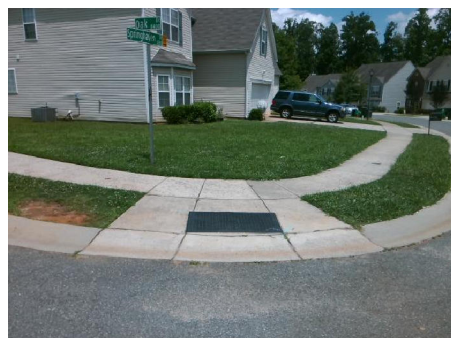
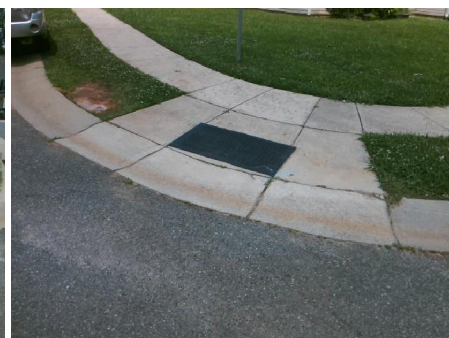
**Not Found, R304.5.1, R304.5.3**

Compliance	Description	Data	Compliance	Description	Data
N/A	Ramp Length (in)	47.0	Yes	Ramp Slope (%)	7.9
No	Ramp Width (in)	39.5	No	Ramp XSlope (%)	3.0
N/A	Flare Type LT	N/A	N/A	Flare Type RT	N/A
N/A	Flare Slope LT (%)	N/A	N/A	Flare Slope RT (%)	N/A
N/A	Flare Traversable LT?	N/A	N/A	Flare Traversable RT?	N/A
N/A	Landing Length (in)	N/A	N/A	DWS Provided?	N/A
N/A	Landing Width (in)	N/A	N/A	DWS Contrast?	N/A
N/A	Landing Slope (%)	N/A	N/A	DWS Length (in)	N/A
N/A	Landing X Slope (%)	N/A	N/A	DWS Full Width?	N/A
N/A	Landing Curb? (Y/N)	N/A	N/A	DWS Offset (in)	N/A
N/A	Shared Landing?	N/A			
N/A	Gutter Ponding?	N/A	N/A	Gutter Slope (%)	N/A
N/A	Gutter Lip Ht (in)	N/A	N/A	Gutter X Slope (%)	N/A
N/A	Painted X Walk1?	No	N/A	Painted X Walk2?	No
	X Walk 1 Direction	To W		X Walk 2 Direction	To S
N/A	X Walk 1 Width (in)	N/A	N/A	X Walk 2 Width (in)	N/A
	X Walk 1 Slope (%)	3.5		X Walk 2 Slope (%)	0.2
	X Walk 1 X Slope (%)	1.6		X Walk 2 X Slope (%)	1.9

N/A	Ramp inside XWalk1?	N/A	N/A	Ramp inside XWalk2?	N/A
	Road Slope (%)	0.5	N/A	Clear Space?	N/A
	Road X Slope (%)	0.5	N/A	Clear Space to XWalk (in)	N/A
N/A	Any Obstructions?	N/A	N/A	Storm Grate/Utility Hazard?	N/A
	Obstruction Type			Storm Grate/Utility Type	
		N/A			N/A
		Yes		Surface Condition? (G/P)	Good

**Remove & Replace Curb Ramp With Two New Directional Ramps or Equivalent.**

Total Cost: \$ 3200.00
