# Access Compliance Report

## Public Rights-of-Way

### (Curb Ramps)

| Intersection ID: 49278 | Main Street: HAMILTON_RD | Cross Street: REUNION_ST | Location: NE |

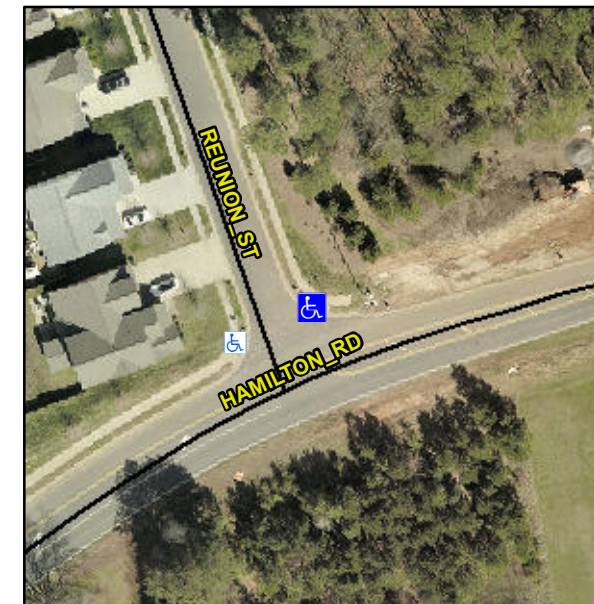
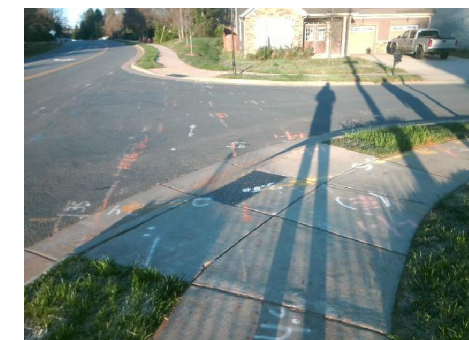
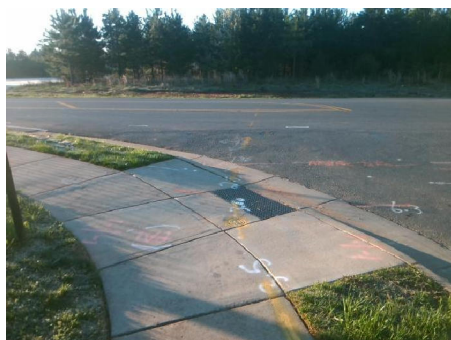
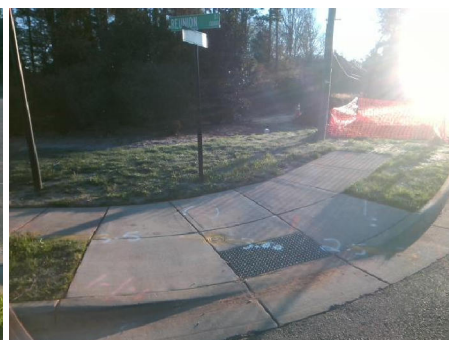
| ADA ID: FA0BFDC1B9FC | Ramp Type: PerpDiag | Initial Pass/Fail: Pass | Overall Compliance: No |

**R304.2.2-Perp, R304.3.2-Para, R304.5.3**

| Compliance | Description | Data | Compliance | Description | Data |
|---|---|---|---|---|---|
| No | Landing Slope (%) | 4.7 | Yes | DWS Length (in) | 24.5 |
| No | Landing X Slope (%) | 4.2 | Yes | DWS Full Width? | Yes |

**Remove & Replace Landing.**

Total Cost: \$ 500.00
