Access Compliance Report Public Rights-of-Way (Curb Ramps)

Intersection ID: 9634 Main Street: MALIBU_DR Cross Street: THE_PLAZA Location: NE

ADA ID: FA1AEFF9F271 Ramp Type: Perp Initial Pass/Fail: Fail Overall Compliance: No Severity Score: 21.25

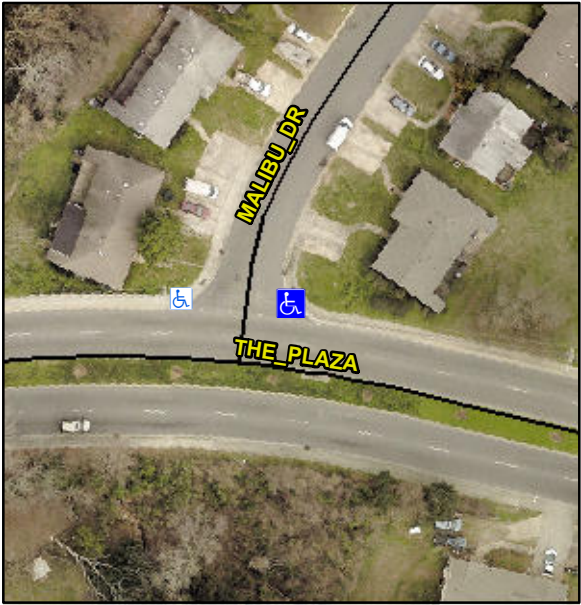
PROW/ADA:
Not Found, R304.5.1, R304.2.2

Compliance	Description	Data	Compliance	Description	Data
N/A	Ramp Length (in)	60.0	No	Ramp Slope (%)	9.1
No	Ramp Width (in)	47.5	Yes	Ramp XSlope (%)	0.6
N/A	Flare Type LT	N/A	N/A	Flare Type RT	N/A
N/A	Flare Slope LT (%)	N/A	N/A	Flare Slope RT (%)	N/A
N/A	Flare Traversable LT?	N/A	N/A	Flare Traversable RT?	N/A
N/A	Landing Length (in)	N/A	N/A	DWS Provided?	N/A
N/A	Landing Width (in)	N/A	N/A	DWS Contrast?	N/A
N/A	Landing Slope (%)	N/A	N/A	DWS Length (in)	N/A
N/A	Landing X Slope (%)	N/A	N/A	DWS Full Width?	N/A
N/A	Landing Curb? (Y/N)	N/A	N/A	DWS Offset (in)	N/A
N/A	Shared Landing?	N/A			
N/A	Gutter Ponding?	N/A	N/A	Gutter Slope (%)	N/A
N/A	Gutter Lip Ht (in)	1.0	N/A	Gutter X Slope (%)	N/A
N/A	Painted X Walk1?	No	N/A	Painted X Walk2?	N/A
	X Walk 1 Direction	To NW		X Walk 2 Direction	N/A
N/A	X Walk 1 Width (in)	N/A	N/A	X Walk 2 Width (in)	N/A
	X Walk 1 Slope (%)	0.1		X Walk 2 Slope (%)	N/A
	X Walk 1 X Slope (%)	1.2		X Walk 2 X Slope (%)	N/A

N/A	Ramp inside XWalk1?	N/A	N/A	Ramp inside XWalk2?	N/A
	Road Slope (%)	N/A	N/A	Clear Space?	N/A
	Road X Slope (%)	N/A	N/A	Clear Space to XWalk (in)	N/A
N/A	Any Obstructions?	N/A	N/A	Storm Grate/Utility Hazard?	N/A
	Obstruction Type			Storm Grate/Utility Type	
		N/A			N/A
			Yes	Surface Condition? (G/P)	Good

Possible Solutions:
Remove & Replace Entire Ramp.
