# Access Compliance Report

## Public Rights-of-Way

### (Curb Ramps)

| Intersection ID: 9696 | Main Street: HERRIN_AV | Cross Street: N_DAVIDSON_ST | Location: SW |

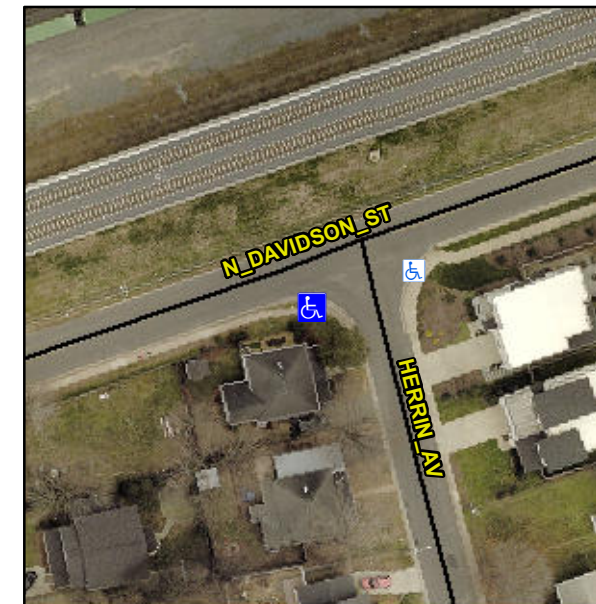
| ADA ID: FA1B04A3E880 | Ramp Type: Perp | Initial Pass/Fail: Fail | Overall Compliance: No |
| | | Severity Score: 12.5 | |

**Not Found, R304.2.2**

| Compliance | Description | Data | Compliance | Description | Data |
|---|---|---|---|---|---|
| N/A | Ramp Length (in) | 68.0 | No | Ramp Slope (%) | 9.1 |

**Remove & Replace Entire Ramp.**

Total Cost: \$ 1850.00
