Access Compliance Report Public Rights-of-Way (Curb Ramps)

Intersection ID: 11740 Main Street: BELMONT_AV Cross Street: N_CALDWELL_ST Location: SE

ADA ID: FA1B2C77525F Ramp Type: PerpDiag Initial Pass/Fail: Fail Overall Compliance: No Severity Score: 46.25

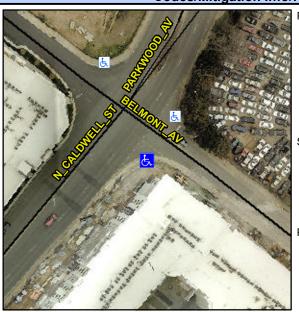
Not Found, R304.5.1, R304.2.2, R304.5.3

Compliance Description Data Compliance Description Data No N/A Ramp Length (in) 61.0 Ramp Slope (%) 9.1 No Ramp XSlope (%) No Ramp Width (in) 43.0 15.0 N/A N/A Flare Type LT N/A Flare Type RT N/A N/A N/A N/A Flare Slope RT (%) N/A Flare Slope LT (%) N/A Flare Traversable LT? N/A N/A Flare Traversable RT? N/A N/A N/A N/A **DWS Provided?** N/A Landing Length (in) N/A Landing Width (in) N/A N/A **DWS Contrast?** N/A N/A N/A Landing Slope (%) N/A DWS Length (in) N/A N/A Landing X Slope (%) N/A N/A DWS Full Width? N/A N/A Landing Curb? (Y/N) N/A N/A DWS Offset (in) N/A N/A N/A Shared Landing? N/A **Gutter Ponding?** N/A N/A Gutter Slope (%) N/A N/A Gutter Lip Ht (in) 2.0 N/A Gutter X Slope (%) N/A N/A Painted X Walk1? No N/A Painted X Walk2? No X Walk 1 Direction To NE X Walk 2 Direction To NW N/A N/A X Walk 1 Width (in) X Walk 2 Width (in) N/A X Walk 1 Slope (%) 3.8 X Walk 2 Slope (%) 5.8 X Walk 1 X Slope (%) 7.5 X Walk 2 X Slope (%) 7.1 N/A N/A N/A Ramp inside XWalk2? N/A Ramp inside XWalk1? Road Slope (%) 9.2 N/A Clear Space? N/A N/A Road X Slope (%) 2.1 Clear Space to XWalk (in) N/A N/A N/A Any Obstructions? N/A Storm Grate/Utility Hazard? N/A

Remove & Replace Curb Ramp With Two New Directional Ramps or Equivalent.
