Access Compliance Report

Public Rights-of-Way

(Curb Ramps)

Intersection ID: N/A	Main Street: MONROE_RD	Cross Street: N/A	Location: NE
ADA ID: FA25F6A5B4C3	Ramp Type: Perp	Initial Pass/Fail: Fail	Overall Compliance: No
			Severity Score: 13.75

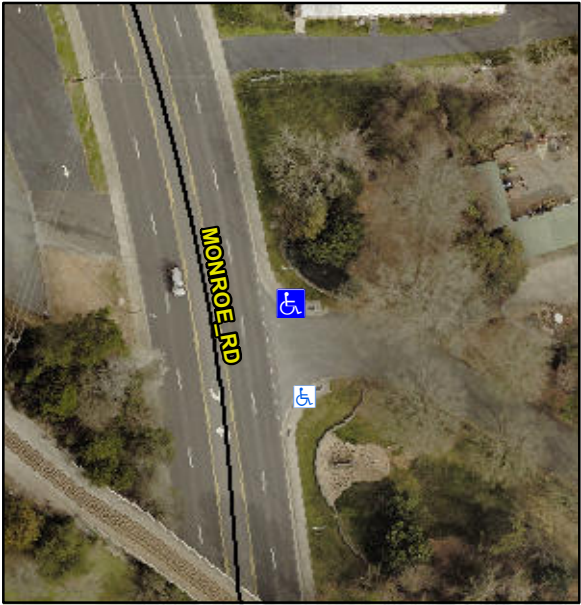
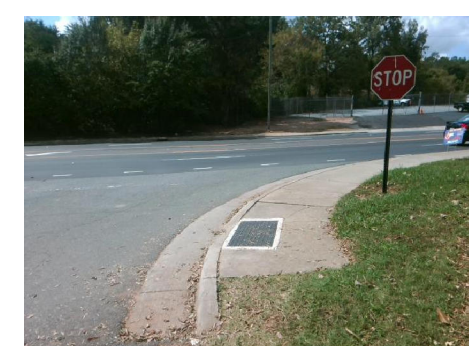
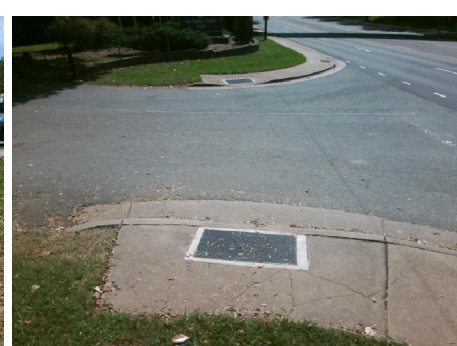
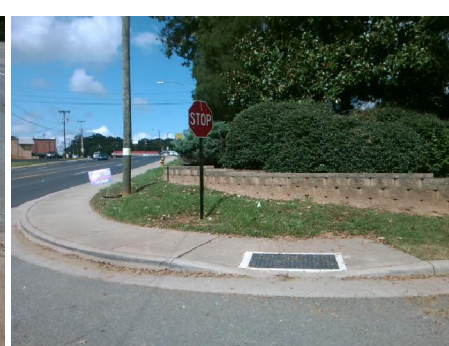
Possible Solutions:		Compliance	Description	Data
	Remove & Replace Entire Ramp.		No	Ramp Length (in)	62.0
			Yes	Ramp Width (in)	48.0
			N/A	Flare Type LT	N/A
			N/A	Flare Slope LT (%)	N/A
			N/A	Flare Traversable LT?	N/A
			N/A	Landing Length (in)	N/A
			N/A	Landing Width (in)	N/A
			N/A	Landing Slope (%)	N/A
			N/A	Landing X Slope (%)	N/A
<p>Surveyor Notes:</p> <p>N/A</p> <p>PROW/ADA:</p> <p>Not Found, R304.2.2, R304.5.3</p>			N/A	Flare Type RT	N/A
			N/A	Flare Slope RT (%)	N/A
			N/A	Flare Traversable RT?	N/A
			N/A	DWS Provided?	N/A
			N/A	DWS Contrast?	N/A
			N/A	DWS Length (in)	N/A
			N/A	DWS Full Width?	N/A
			N/A	DWS Offset (in)	N/A
			N/A	Shared Landing?	N/A
			N/A	Gutter Ponding?	N/A
			N/A	Gutter Lip Ht (in)	N/A
			N/A	Painted X Walk1?	No
				X Walk 1 Direction	To S
			N/A	X Walk 1 Width (in)	N/A
				X Walk 1 Slope (%)	5.9

X Walk 1 X Slope (%)	3.7
			N/A	Ramp inside XWalk1?	N/A
			N/A	Road Slope (%)	N/A
			N/A	Road X Slope (%)	N/A
			N/A	Any Obstructions?	N/A
Total Cost:		\$ 1850.00		Obstruction Type	
			N/A	Storm Grate/Utility Hazard?	N/A
				Storm Grate/Utility Type	
			N/A		N/A
			Yes	Surface Condition? (G/P)	Good
