## Access Compliance Report Public Rights-of-Way (Curb Ramps)

Intersection ID: 15396Main Street:MUSEUM\_PLAZACross Street:RANDOLPH\_RDLocation:SADA ID: FA650629508ARamp Type:PerpDiagInitial Pass/Fail:FailOverall Compliance:NoSeverity Score:13.75

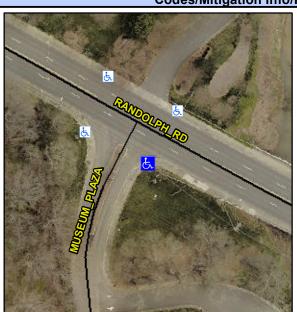
Field Measurements/Component Compliance							
Compliance Description		Data	Comp	liance Description	Data		
N/A	Ramp Length (in)	72.0	No	Ramp Slope (%)	10.2		
Yes	Ramp Width (in)	48.0	No	Ramp XSlope (%)	3.3		
N/A	Flare Type LT	N/A	N/A	Flare Type RT	N/A		
N/A	Flare Slope LT (%)	N/A	N/A	Flare Slope RT (%)	N/A		
N/A	Flare Traversable LT?	N/A	N/A	Flare Traversable RT?	N/A		
N/A	Landing Length (in)	N/A	N/A	DWS Provided?	N/A		
N/A	Landing Width (in)	N/A	N/A	DWS Contrast?	N/A		
N/A	Landing Slope (%)	N/A	N/A	DWS Length (in)	N/A		
N/A	Landing X Slope (%)	N/A	N/A	DWS Full Width?	N/A		
N/A	Landing Curb? (Y/N)	N/A	N/A	DWS Offset (in)	N/A		
N/A	Shared Landing?	N/A					
N/A	Gutter Ponding?	N/A	N/A	Gutter Slope (%)	N/A		
N/A	Gutter Lip Ht (in)	N/A	N/A	Gutter X Slope (%)	N/A		
N/A	Painted X Walk1?	No	N/A	Painted X Walk2?	No		
	X Walk 1 Direction	To NE		X Walk 2 Direction	To NW		
N/A	X Walk 1 Width (in)	N/A	N/A	X Walk 2 Width (in)	N/A

X Walk 1 Slope (%)	5.5		X Walk 2 Slope (%)	2.1		
	X Walk 1 X Slope (%)	1.6		X Walk 2 X Slope (%)	6.2		
N/A	Ramp inside XWalk1?	N/A	N/A	Ramp inside XWalk2?	N/A		
	Road Slope (%)	2.7	N/A	Clear Space?	N/A		
	Road X Slope (%)	5.1	N/A	Clear Space to XWalk (in)	N/A		
N/A	Any Obstructions?	N/A	N/A	Storm Grate/Utility Hazard?	N/A		
	Obstruction Type		l	Storm Grate/Utility Type			
		N/A			N/A		
			Yes	Surface Condition? (G/P)	Good

Possible Solution	
Possible Solutions:	
Remove & Replace Curb Ramp With Two New Directional Ramps or Equivalent.	, ,
Surveyor Notes:	
N/A	
PROW/ADA:	
Not Found, R304.2.2, R304.5.3	1
	I
