Access Compliance Report

Public Rights-of-Way

(Curb Ramps)

Intersection ID: 52127	Main Street: VALLEYDALE_RD	Cross Street: FRED_D_ALEXANDER_BV	Location: E
ADA ID: FA697F09D828	Ramp Type: Combination1	Initial Pass/Fail: Pass	Overall Compliance: No
			Severity Score: 7.5

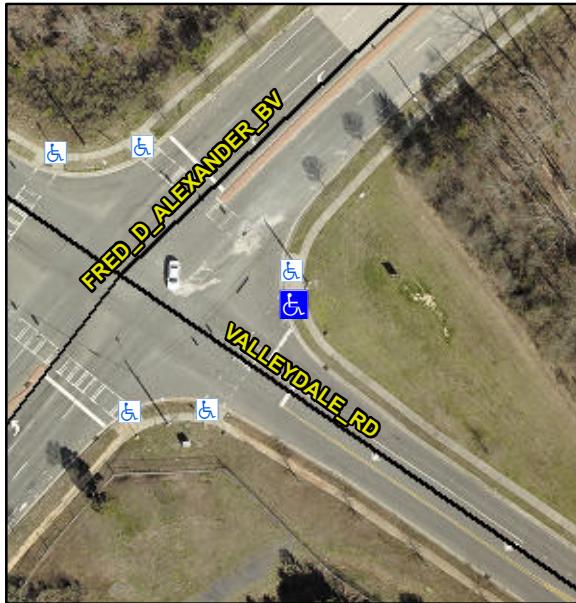
GTR GAP 1.5", RP < 5%

**Not Found, R305.1.4, R305.2,
R304.5.4**

**Remove & Replace Entire Ramp.
Remove & Replace Gutter.**
