# Access Compliance Report

## Public Rights-of-Way

### (Curb Ramps)

Intersection ID: 11200	Main Street: MILTON_RD	Cross Street: VILLAGE_GREEN_DR	Location: SE
ADA ID: FA745010D2F0	Ramp Type: Perp	Initial Pass/Fail: Fail	Overall Compliance: No
Codes/Mitigation Info/Possible Solution			Severity Score: 10
			Field Measurements/Component Compliance

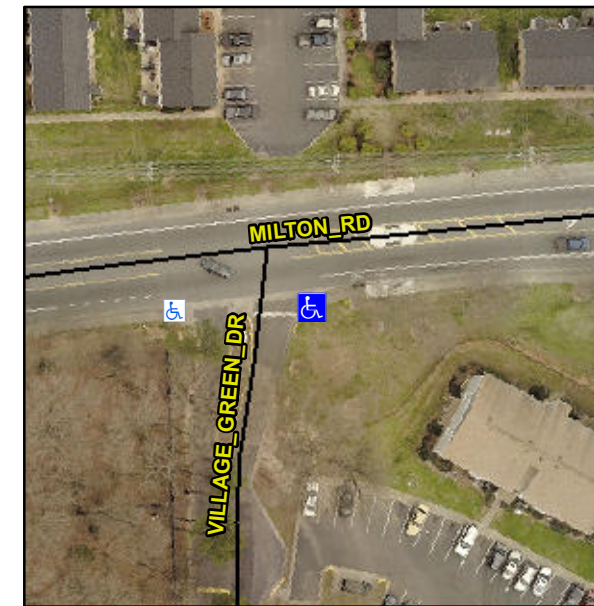
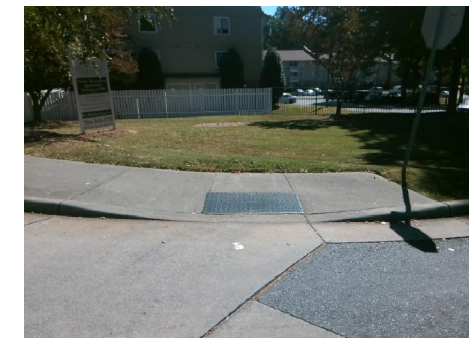
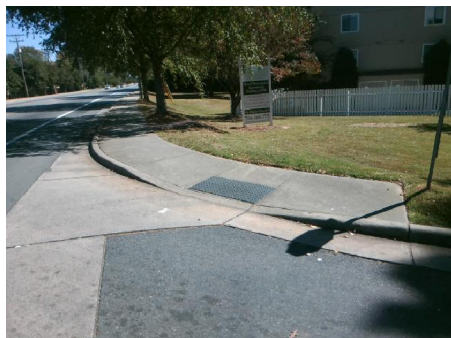
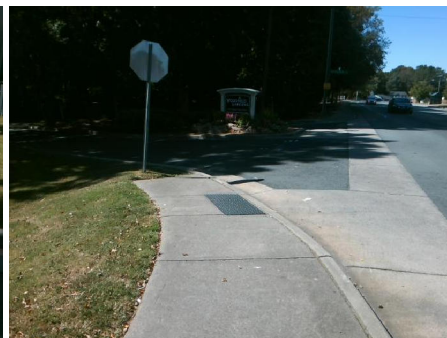
**Not Found, R304.5.1, R304.5.3**

Compliance	Description	Data	Compliance	Description	Data
N/A	Ramp Length (in)	59.5	Yes	Ramp Slope (%)	7.3
No	Ramp Width (in)	41.5	No	Ramp XSlope (%)	4.0
N/A	Flare Type LT	N/A	N/A	Flare Type RT	N/A
N/A	Flare Slope LT (%)	N/A	N/A	Flare Slope RT (%)	N/A
N/A	Flare Traversable LT?	N/A	N/A	Flare Traversable RT?	N/A
N/A	Landing Length (in)	N/A	N/A	DWS Provided?	N/A
N/A	Landing Width (in)	N/A	N/A	DWS Contrast?	N/A
N/A	Landing Slope (%)	N/A	N/A	DWS Length (in)	N/A
N/A	Landing X Slope (%)	N/A	N/A	DWS Full Width?	N/A
N/A	Landing Curb? (Y/N)	N/A	N/A	DWS Offset (in)	N/A
N/A	Shared Landing?	N/A			
N/A	Gutter Ponding?	N/A	N/A	Gutter Slope (%)	N/A
N/A	Gutter Lip Ht (in)	N/A	N/A	Gutter X Slope (%)	N/A
N/A	Painted X Walk1?	No	N/A	Painted X Walk2?	N/A
	X Walk 1 Direction	To W		X Walk 2 Direction	N/A
N/A	X Walk 1 Width (in)	N/A	N/A	X Walk 2 Width (in)	N/A
	X Walk 1 Slope (%)	1.2		X Walk 2 Slope (%)	N/A
	X Walk 1 X Slope (%)	8.1		X Walk 2 X Slope (%)	N/A

N/A	Ramp inside XWalk1?	N/A	N/A	Ramp inside XWalk2?	N/A
	Road Slope (%)	N/A	N/A	Clear Space?	N/A
	Road X Slope (%)	N/A	N/A	Clear Space to XWalk (in)	N/A
N/A	Any Obstructions?	N/A	N/A	Storm Grate/Utility Hazard?	N/A
	Obstruction Type			Storm Grate/Utility Type	
		N/A			N/A
			Yes	Surface Condition? (G/P)	Good

**Remove & Replace Entire Ramp.**

Total Cost: \$ 1850.00
