Access Compliance Report

Public Rights-of-Way

(Curb Ramps)

Intersection ID: 20567	Main Street: PARK_SOUTH_DR	Cross Street: PINE_VALLEY_RD	Location: NW
ADA ID: FA7B68305FFD	Ramp Type: PerpDiag	Initial Pass/Fail: Fail	Overall Compliance: No
			Severity Score: 21.25

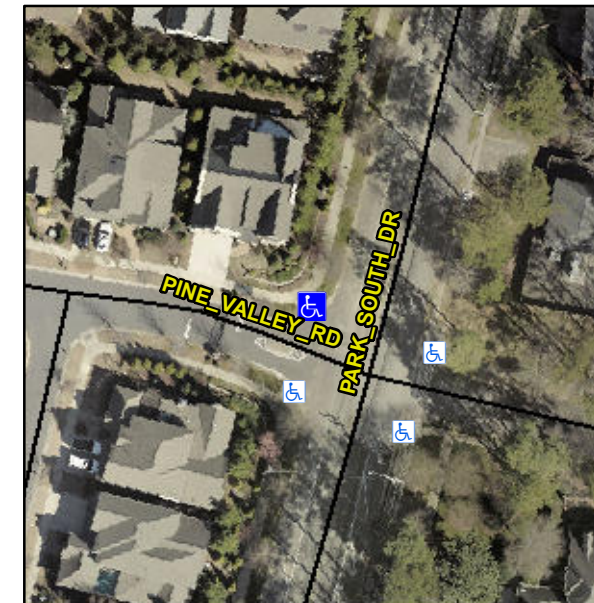
Not Found, R304.5.1, R304.5.3

Compliance	Description	Data	Compliance	Description	Data
N/A	Ramp Length (in)	100.0	Yes	Ramp Slope (%)	6.4
No	Ramp Width (in)	47.5	No	Ramp XSlope (%)	6.5
N/A	Flare Type LT	N/A	N/A	Flare Type RT	N/A
N/A	Flare Slope LT (%)	N/A	N/A	Flare Slope RT (%)	N/A
N/A	Flare Traversable LT?	N/A	N/A	Flare Traversable RT?	N/A
N/A	Landing Length (in)	N/A	N/A	DWS Provided?	N/A
N/A	Landing Width (in)	N/A	N/A	DWS Contrast?	N/A
N/A	Landing Slope (%)	N/A	N/A	DWS Length (in)	N/A
N/A	Landing X Slope (%)	N/A	N/A	DWS Full Width?	N/A
N/A	Landing Curb? (Y/N)	N/A	N/A	DWS Offset (in)	N/A
N/A	Shared Landing?	N/A			
N/A	Gutter Ponding?	N/A	N/A	Gutter Slope (%)	N/A
N/A	Gutter Lip Ht (in)	N/A	N/A	Gutter X Slope (%)	N/A
N/A	Painted X Walk1?	No	N/A	Painted X Walk2?	No
	X Walk 1 Direction	To SW		X Walk 2 Direction	To SE
N/A	X Walk 1 Width (in)	N/A	N/A	X Walk 2 Width (in)	N/A
	X Walk 1 Slope (%)	2.4		X Walk 2 Slope (%)	4.0
	X Walk 1 X Slope (%)	3.9		X Walk 2 X Slope (%)	3.3

N/A	Ramp inside XWalk1?	N/A	N/A	Ramp inside XWalk2?	N/A
	Road Slope (%)	5.3	N/A	Clear Space?	N/A
	Road X Slope (%)	0.6	N/A	Clear Space to XWalk (in)	N/A
N/A	Any Obstructions?	N/A	N/A	Storm Grate/Utility Hazard?	N/A
	Obstruction Type			Storm Grate/Utility Type	
		N/A			N/A
			Yes	Surface Condition? (G/P)	Good

Remove & Replace Curb Ramp With Two New Directional Ramps or Equivalent.
