Access Compliance Report

Public Rights-of-Way

(Curb Ramps)

Intersection ID: N/A	Main Street: NEW_FASHION_WY	Cross Street: OUTLETS_BV	Location: SW
ADA ID: FA850C970A1A	Ramp Type: Perp	Initial Pass/Fail: Fail	Overall Compliance: No
Severity Score: 21.25			
Codes/Mitigation Info/Possible Solution		Field Measurements/Component Compliance

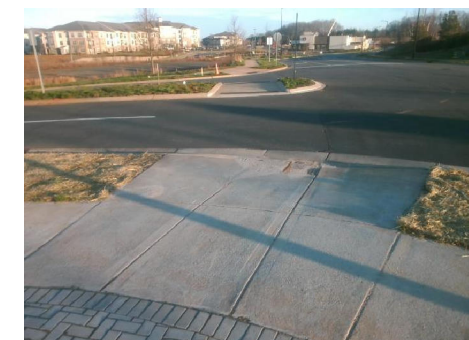
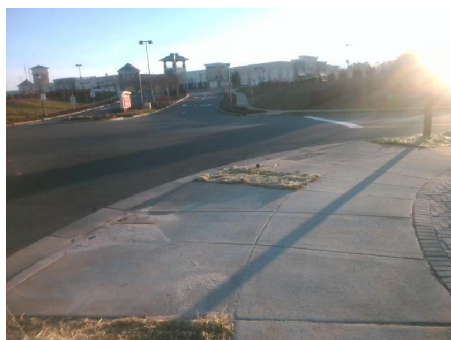
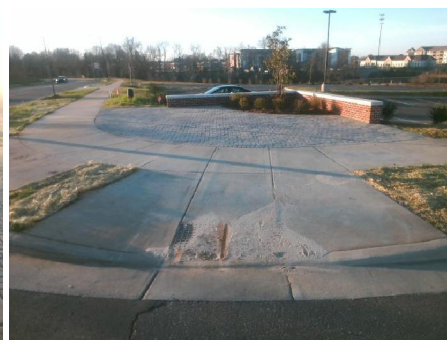
R304.5.1, R304.5.3

Compliance	Description	Data	Compliance	Description	Data
N/A	Ramp Length (in)	98.0	Yes	Ramp Slope (%)	7.6
No	Ramp Width (in)	45.0	No	Ramp XSlope (%)	5.2
N/A	Flare Type LT	N/A	N/A	Flare Type RT	N/A
N/A	Flare Slope LT (%)	N/A	N/A	Flare Slope RT (%)	N/A
N/A	Flare Traversable LT?	N/A	N/A	Flare Traversable RT?	N/A
N/A	Landing Length (in)	N/A	N/A	DWS Provided?	N/A
N/A	Landing Width (in)	N/A	N/A	DWS Contrast?	N/A
N/A	Landing Slope (%)	N/A	N/A	DWS Length (in)	N/A
N/A	Landing X Slope (%)	N/A	N/A	DWS Full Width?	N/A
N/A	Landing Curb? (Y/N)	N/A	N/A	DWS Offset (in)	N/A
N/A	Shared Landing?	N/A			
N/A	Gutter Ponding?	N/A	N/A	Gutter Slope (%)	N/A
N/A	Gutter Lip Ht (in)	N/A	N/A	Gutter X Slope (%)	N/A
N/A	Painted X Walk1?	No	N/A	Painted X Walk2?	N/A
	X Walk 1 Direction	To NW		X Walk 2 Direction	N/A
N/A	X Walk 1 Width (in)	N/A	N/A	X Walk 2 Width (in)	N/A
	X Walk 1 Slope (%)	4.5		X Walk 2 Slope (%)	N/A
	X Walk 1 X Slope (%)	2.1		X Walk 2 X Slope (%)	N/A

N/A	Ramp inside XWalk1?	N/A	N/A	Ramp inside XWalk2?	N/A
	Road Slope (%)	N/A	N/A	Clear Space?	N/A
	Road X Slope (%)	N/A	N/A	Clear Space to XWalk (in)	N/A
N/A	Any Obstructions?	N/A	N/A	Storm Grate/Utility Hazard?	N/A
	Obstruction Type			Storm Grate/Utility Type	
		N/A			N/A
			Yes	Surface Condition? (G/P)	Good

Possible Solutions:

Remove & Replace Entire Ramp.
