Access Compliance Report

Public Rights-of-Way

(Curb Ramps)

Intersection ID: 15568	Main Street: KENILWORTH_AV	Cross Street: ORDERMORE_AV	Location: W
ADA ID: FA86AC6357B0	Ramp Type: Directional1	Initial Pass/Fail: Fail	Overall Compliance: No
		Severity Score: 25

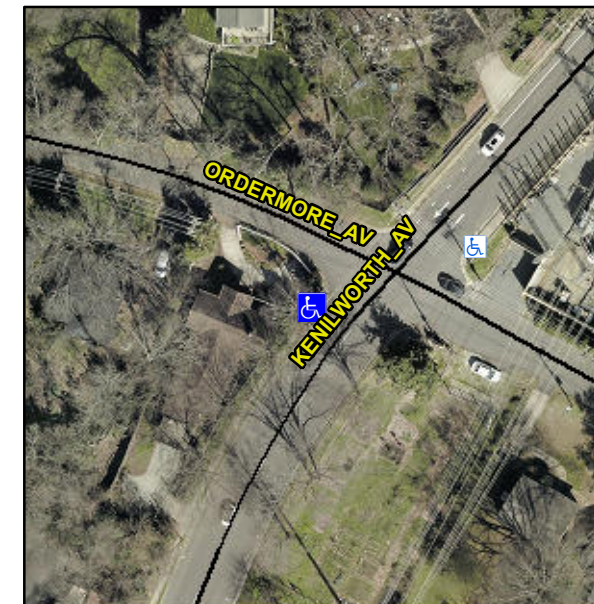
R304.5.3

Compliance	Description	Data	Compliance	Description	Data
N/A	Ramp Length (in)	64.0	N/A	Grade Break?	N/A
Yes	Ramp Width (in)	48.0	N/A	Grade Break Slope (%)	0.0
Yes	Ramp Slope (%)	1.5	N/A	Grade Break XSlope (%)	0.0
No	Ramp XSlope (%)	10.3			
N/A	Flare Type LT	N/A	N/A	Flare Type RT	N/A
N/A	Flare Slope LT (%)	N/A	N/A	Flare Slope RT (%)	0.0
N/A	Flare Traversable LT?	N/A	N/A	Flare Traversable RT?	N/A
N/A	Landing Length (in)	0.0	N/A	DWS Provided?	N/A
N/A	Landing Width (in)	0.0	N/A	DWS Contrast?	N/A
N/A	Landing Slope (%)	0.0	N/A	DWS Length (in)	N/A
N/A	Landing X Slope (%)	0.0	N/A	DWS Full Width?	N/A
N/A	Landing Curb? (Y/N)	N/A	N/A	DWS Offset LT (in)	N/A
N/A	Shared Landing?	N/A	N/A	DWS Offset RT (in)	N/A
N/A	Gutter Ponding?	0.0	N/A	Gutter Slope (%)	N/A
N/A	Gutter Lip Ht (in)	0.0	N/A	Gutter X Slope (%)	N/A
N/A	Painted X Walk1?	No		Road Slope (%)	8.3
	X Walk 1 Direction	To NE		Road X Slope (%)	8.4
	X Walk 1 Width (in)	N/A		Clear Space?	N/A

X Walk 1 Slope (%)	8.3	N/A	Clear Space to XWalk (in)	N/A
	X Walk 1 X Slope (%)	8.4	N/A	Storm Grate/Utility Hazard?	N/A
N/A	Ramp inside XWalk1?	N/A		Storm Grate/Utility Type	
N/A	Any Obstructions?	N/A			N/A
	Obstruction Type		Yes	Surface Condition? (G/P)	Good
			N/A	Curb Slope (%)	7.5

Remove & Replace Entire Ramp.

\$ 1600.00
