## Access Compliance Report Public Rights-of-Way (Curb Ramps)

Intersection ID: 7128Main Street:DALECREST\_DRCross Street:KENMONT\_DRLocation:WADA ID: FAA96E6220D9Ramp Type:PerpInitial Pass/Fail:FailOverall Compliance:NoSeverity Score:8.75

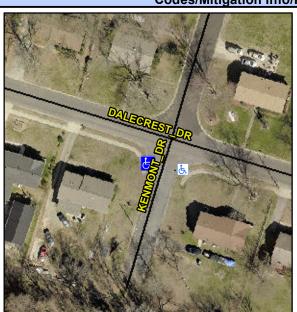
Field Measurements/Component Compliance										
Compliance Description			Data	Compli	ance Description	Data				
	N/A	Ramp Length (in)	47.5	Yes	Ramp Slope (%)	8.3				
	No	Ramp Width (in)	37.5	Yes	Ramp XSlope (%)	1.2				
	N/A	Flare Type LT	N/A	N/A	Flare Type RT	N/A				
	N/A	Flare Slope LT (%)	N/A	N/A	Flare Slope RT (%)	N/A				
	N/A	Flare Traversable LT?	N/A	N/A	Flare Traversable RT?	N/A				
	N/A	Landing Length (in)	N/A	N/A	DWS Provided?	N/A				
	N/A	Landing Width (in)	N/A	N/A	DWS Contrast?	N/A				
	N/A	Landing Slope (%)	N/A	N/A	DWS Length (in)	N/A				
	N/A	Landing X Slope (%)	N/A	N/A	DWS Full Width?	N/A				
	N/A	Landing Curb? (Y/N)	N/A	N/A	DWS Offset (in)	N/A				
	N/A	Shared Landing?	N/A							
	N/A	Gutter Ponding?	N/A	N/A	Gutter Slope (%)	N/A				
	N/A	Gutter Lip Ht (in)	N/A	N/A	Gutter X Slope (%)	N/A				
	N/A	Painted X Walk1?	No	N/A	Painted X Walk2?	N/A				
		X Walk 1 Direction	To SE		X Walk 2 Direction	N/A

N/A	X Walk 1 Width (in)	N/A	N/A	X Walk 2 Width (in)	N/A				
		X Walk 1 Slope (%)	3.2		X Walk 2 Slope (%)	N/A				
		X Walk 1 X Slope (%)	2.1		X Walk 2 X Slope (%)	N/A				
	N/A	Ramp inside XWalk1?	N/A	N/A	Ramp inside XWalk2?	N/A				
		Road Slope (%)	N/A	N/A	Clear Space?	N/A				
		Road X Slope (%)	N/A	N/A	Clear Space to XWalk (in)	N/A				
	N/A	Any Obstructions?	N/A	N/A	Storm Grate/Utility Hazard?	N/A				
		Obstruction Type			Storm Grate/Utility Type					
			N/A			N/A

POSSIBLE SOLUTION	
Possible Solutions:	Co
Remove & Replace Entire Ramp.	N/A
	No
	N/A
	N/A
	N/A
	N/A
Surveyor Notes:	N/A
N/A	N/A
	N/A
	N/A
	N/A
PROW/ADA:	N/A
Not Found, R304.5.1	N/A
·	N/A
	N/
	N/A
	14/7
