## Access Compliance Report Public Rights-of-Way (Curb Ramps)

Intersection ID: 21160 Main Street: SHARON\_VIEW\_RD Cross Street: VALENCIA\_TR Location: NE

ADA ID: FAAFF4718A1B Ramp Type: PerpDiag Initial Pass/Fail: Fail Overall Compliance: No Severity Score: 33.75

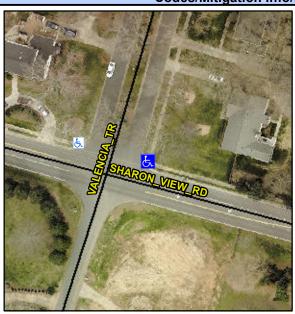
Not Found, R304.5.1, R304.2.2, R304.5.3

Field Measurements/Component Compliance							
	Compl	iance Description	Data	Compliance		Description	Data
	N/A	Ramp Length (in)	37.3	No	Ramp	Slope (%)	9.6
	No	Ramp Width (in)	43.5	No	Ramp	XSlope (%)	6.0
	N/A	Flare Type LT	N/A	N/A	Flare	Type RT	N/A
	N/A	Flare Slope LT (%)	N/A	N/A	Flare	Slope RT (%)	N/A
	N/A	Flare Traversable LT?	N/A	N/A	Flare	Traversable RT?	N/A
	N/A	Landing Length (in)	N/A	N/A	DWS	Provided?	N/A
	N/A	Landing Width (in)	N/A	N/A	DWS	Contrast?	N/A
	N/A	Landing Slope (%)	N/A	N/A	DWS	Length (in)	N/A
	N/A	Landing X Slope (%)	N/A	N/A	DWS	Full Width?	N/A
	N/A	Landing Curb? (Y/N)	N/A	N/A	DWS	Offset (in)	N/A
	N/A	Shared Landing?	N/A				
	N/A	Gutter Ponding?	N/A	N/A	Gutte	r Slope (%)	N/A
	N/A	Gutter Lip Ht (in)	N/A	N/A	Gutte	r X Slope (%)	N/A
	N/A	Painted X Walk1?	No	N/A	Painte	ed X Walk2?	No
		X Walk 1 Direction	To NW		X Wa	lk 2 Direction	To SW
	N/A	X Walk 1 Width (in)	N/A	N/A	X Wa	lk 2 Width (in)	N/A

X Walk 1 Slope (%)	3.4		X Wa	lk 2 Slope (%)	2.9
		X Walk 1 X Slope (%)	7.3		X Wa	lk 2 X Slope (%)	0.3
	N/A	Ramp inside XWalk1?	N/A	N/A	Ramp	inside XWalk2?	N/A
		Road Slope (%)	5.0	N/A	Clear	Space?	N/A
		Road X Slope (%)	12.5	N/A	Clear	Space to XWalk (in)	N/A
	N/A	Any Obstructions?	N/A	N/A	Storm	n Grate/Utility Hazard?	N/A
		Obstruction Type			Storm	n Grate/Utility Type	
			N/A				N/A
				Yes	Surfa	ce Condition? (G/P)	Good

Remove & Replace Curb Ramp With Two New Directional Ramps or Equivalent.
