Access Compliance Report

Public Rights-of-Way

(Curb Ramps)

Intersection ID: N/A	Main Street: HAMILTON_BRIDGE_RD	Cross Street: OBAN_PASSAGE_DR	Location: NW
ADA ID: FAD9C31B2AEB	Ramp Type: Perp	Initial Pass/Fail: Fail	Overall Compliance: No
Severity Score: 22.5			
Codes/Mitigation Info/Possible Solution		Field Measurements/Component Compliance

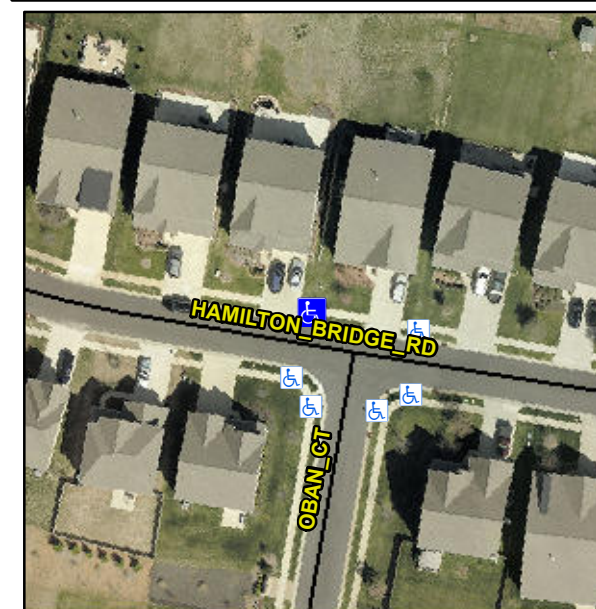
Not Found, R304.5.1, R304.2.2

Compliance	Description	Data	Compliance	Description	Data
N/A	Ramp Length (in)	48.0	No	Ramp Slope (%)	9.3
No	Ramp Width (in)	47.0	Yes	Ramp XSlope (%)	4.7
N/A	Flare Type LT	N/A	N/A	Flare Type RT	N/A
N/A	Flare Slope LT (%)	N/A	N/A	Flare Slope RT (%)	N/A
N/A	Flare Traversable LT?	N/A	N/A	Flare Traversable RT?	N/A
N/A	Landing Length (in)	N/A	N/A	DWS Provided?	N/A
N/A	Landing Width (in)	N/A	N/A	DWS Contrast?	N/A
N/A	Landing Slope (%)	N/A	N/A	DWS Length (in)	N/A
N/A	Landing X Slope (%)	N/A	N/A	DWS Full Width?	N/A
N/A	Landing Curb? (Y/N)	N/A	N/A	DWS Offset (in)	N/A
N/A	Shared Landing?	N/A			
N/A	Gutter Ponding?	N/A	N/A	Gutter Slope (%)	N/A
N/A	Gutter Lip Ht (in)	1.0	N/A	Gutter X Slope (%)	N/A
N/A	Painted X Walk1?	No	N/A	Painted X Walk2?	N/A
	X Walk 1 Direction	To SW		X Walk 2 Direction	N/A
N/A	X Walk 1 Width (in)	N/A	N/A	X Walk 2 Width (in)	N/A
	X Walk 1 Slope (%)	0.8		X Walk 2 Slope (%)	N/A
	X Walk 1 X Slope (%)	4.9		X Walk 2 X Slope (%)	N/A

N/A	Ramp inside XWalk1?	N/A	N/A	Ramp inside XWalk2?	N/A
	Road Slope (%)	N/A	N/A	Clear Space?	N/A
	Road X Slope (%)	N/A	N/A	Clear Space to XWalk (in)	N/A
N/A	Any Obstructions?	N/A	N/A	Storm Grate/Utility Hazard?	N/A
	Obstruction Type			Storm Grate/Utility Type	
		N/A			N/A
			Yes	Surface Condition? (G/P)	Good

Remove & Replace Entire Ramp.

Total Cost: \$ 1850.00
