Access Compliance Report Public Rights-of-Way (Curb Ramps)

Intersection ID: 10019463Main Street: ALEXANDER_MARTIN_AVCross Street: N/ALocation:NADA ID: FADF4FD205B5Ramp Type: PerpInitial Pass/Fail: FailOverall Compliance: NoSeverity Score: 22.5

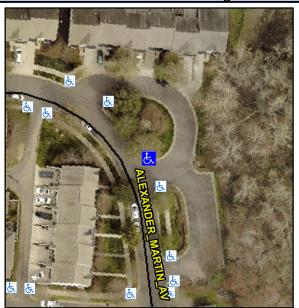
Field Measurements/Component Compilance							
Con	pliance Description	Data	Comp	liance Description	Data		
N/A	Ramp Length (in)	51.0	No	Ramp Slope (%)	8.6		
No	Ramp Width (in)	46.0	Yes	Ramp XSlope (%)	2.6		
N/A	Flare Type LT	N/A	N/A	Flare Type RT	N/A		
N/A	Flare Slope LT (%)	N/A	N/A	Flare Slope RT (%)	N/A		
N/A	Flare Traversable LT?	N/A	N/A	Flare Traversable RT?	N/A		
N/A	Landing Length (in)	N/A	N/A	DWS Provided?	N/A		
N/A	Landing Width (in)	N/A	N/A	DWS Contrast?	N/A		
N/A	Landing Slope (%)	N/A	N/A	DWS Length (in)	N/A		
N/A	Landing X Slope (%)	N/A	N/A	DWS Full Width?	N/A		
N/A	Landing Curb? (Y/N)	N/A	N/A	DWS Offset (in)	N/A		
N/A	Shared Landing?	N/A					
N/A	Gutter Ponding?	N/A	N/A	Gutter Slope (%)	N/A		
N/A	Gutter Lip Ht (in)	N/A	N/A	Gutter X Slope (%)	N/A		
N/A	Painted X Walk1?	No	N/A	Painted X Walk2?	N/A		
	X Walk 1 Direction	To SE		X Walk 2 Direction	N/A		
N/A	X Walk 1 Width (in)	N/A	N/A	X Walk 2 Width (in)	N/A

X Walk 1 Slope (%)	2.4		X Walk 2 Slope (%)	N/A		
	X Walk 1 X Slope (%)	3.8		X Walk 2 X Slope (%)	N/A		
N/A	Ramp inside XWalk1?	N/A	N/A	Ramp inside XWalk2?	N/A		
	Road Slope (%)	N/A	N/A	Clear Space?	N/A		
	Road X Slope (%)	N/A	N/A	Clear Space to XWalk (in)	N/A		
N/A	Any Obstructions?	N/A	N/A	Storm Grate/Utility Hazard?	N/A		
	Obstruction Type			Storm Grate/Utility Type			
		N/A			N/A		
			Yes	Surface Condition? (G/P)	Good		
PXE

1 0331bic Ocidiion	
Possible Solutions:	C
Remove & Replace Entire Ramp.	
	No
	N/
	N/
	N/
	N/
Surveyor Notes:	N/
N/A	N/
	N/
	N/
	N/
PROW/ADA:	N/
Not Found, R304.5.1, R304.2.2	N/
	N/
	N/
	N/
