Access Compliance Report Public Rights-of-Way (Curb Ramps)

Intersection ID: 22376 Main Street: CREEK VALLEY DR **Cross Street: SARDIS RD** Location:

ADA ID: FAECE986E7BB Ramp Type: PerpDiag Initial Pass/Fail: Fail **Overall Compliance: No** Severity Score: 33.75

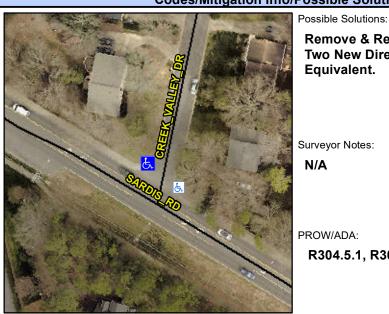
R304.5.1, R304.5.3

| Field Measurements/Component Compliance | | | | | | | | |
|---|---|---|---|---|---|--|--|--|
| N/A | Ramp Length (in) | 59.0 | Yes | Ramp Slope (%) | 6.9 | | | |
| No | Ramp Width (in) | 47.0 | No | Ramp XSlope (%) | 8.0 | | | |

Remove & Replace Curb Ramp With Two New Directional Ramps or Equivalent. Surveyor Notes:
