# Access Compliance Report

## Public Rights-of-Way

### (Curb Ramps)

Intersection ID: N/A	Main Street: E 8TH ST	Cross Street: N BREVARD ST	Location: E
ADA ID: FAF3244416FC	Ramp Type: Perp	Initial Pass/Fail: Fail	Overall Compliance: No
Severity Score: 12.5			
Codes/Mitigation Info/Possible Solution		Field Measurements/Component Compliance

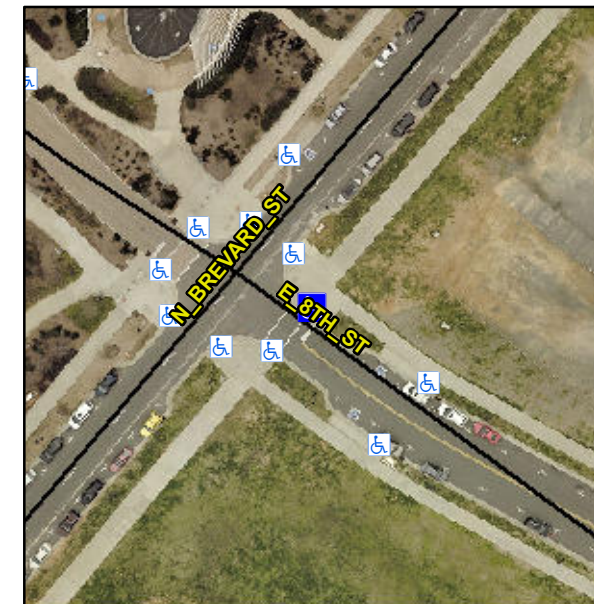
**Not Found, R304.5.3**

Compliance	Description	Data	Compliance	Description	Data
N/A	Ramp Length (in)	85.5	Yes	Ramp Slope (%)	6.8
Yes	Ramp Width (in)	48.0	No	Ramp XSlope (%)	5.4
N/A	Flare Type LT	N/A	N/A	Flare Type RT	N/A
N/A	Flare Slope LT (%)	N/A	N/A	Flare Slope RT (%)	N/A
N/A	Flare Traversable LT?	No	N/A	Flare Traversable RT?	No
N/A	Landing Length (in)	N/A	N/A	DWS Provided?	N/A
N/A	Landing Width (in)	N/A	N/A	DWS Contrast?	N/A
N/A	Landing Slope (%)	N/A	N/A	DWS Length (in)	N/A
N/A	Landing X Slope (%)	N/A	N/A	DWS Full Width?	N/A
N/A	Landing Curb? (Y/N)	N/A	N/A	DWS Offset (in)	N/A
N/A	Shared Landing?	N/A			
N/A	Gutter Ponding?	N/A	N/A	Gutter Slope (%)	N/A
N/A	Gutter Lip Ht (in)	N/A	N/A	Gutter X Slope (%)	N/A
N/A	Painted X Walk1?	Yes	N/A	Painted X Walk2?	N/A
	X Walk 1 Direction	To SW		X Walk 2 Direction	N/A
N/A	X Walk 1 Width (in)	112.0	N/A	X Walk 2 Width (in)	N/A
	X Walk 1 Slope (%)	3.0		X Walk 2 Slope (%)	N/A
	X Walk 1 X Slope (%)	3.0		X Walk 2 X Slope (%)	N/A

N/A	Ramp inside XWalk1?	Yes	N/A	Ramp inside XWalk2?	N/A
	Road Slope (%)	N/A	N/A	Clear Space?	N/A
	Road X Slope (%)	N/A	N/A	Clear Space to XWalk (in)	N/A
N/A	Any Obstructions?	N/A	N/A	Storm Grate/Utility Hazard?	N/A
	Obstruction Type			Storm Grate/Utility Type	
		N/A			N/A
			Yes	Surface Condition? (G/P)	Good

**Remove & Replace Entire Ramp.**

Total Cost: \$ 1850.00
