Access Compliance Report Public Rights-of-Way (Curb Ramps)

•		-					
Intersection ID: 31402	Main Str	Main Street: CHEVIOTT_HILL_LN			WENTWATER_ST	Location:	NW		
ADA ID: FAFC49D0FE2D	Ramp Ty	Ramp Type: PerpDiag			Initial Pass/Fail: Fail Overall Compliance: No				21.25
Codes/Mitigation Info/Possible Solution				Field Measurements/Component Compliance					
		Possible Solutions:		Compliance Description			Data Compliance Description		
		Remove & Replace Curb Ramp W	/ith	N/A	Ramp Length (in)	46.5	No	Ramp Slope (%)	9.1
		Two New Directional Ramps or		No	Ramp Width (in)	47.0	Yes	Ramp XSlope (%)	0.4
		Equivalent.		N/A	Flare Type LT	N/A	N/A	Flare Type RT	N/A
				N/A	Flare Slope LT (%)	N/A	N/A	Flare Slope RT (%)	N/A
Ta 2 and all 12				N/A	Flare Traversable LT?	N/A	N/A	Flare Traversable RT?	N/A
				N/A	Landing Length (in)	N/A	N/A	DWS Provided?	N/A
		Surveyor Notes:		N/A	Landing Width (in)	N/A	N/A	DWS Contrast?	N/A
		N/A		N/A	Landing Slope (%)	N/A	N/A	DWS Length (in)	N/A

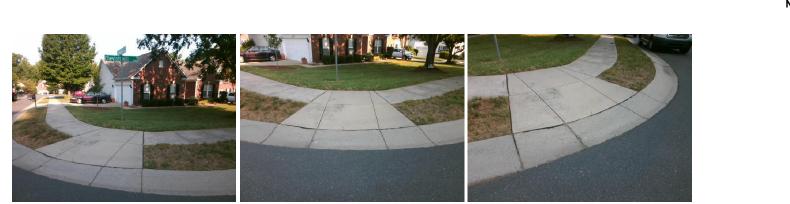
1//2		N/A	Landing X Slope (%)	N/A	N/A	DWS Full Width?	N/A
MATER DU &	The second			N/A	Landing Curb? (Y/N)	N/A	N/A	DWS Offset (in)	N/A
VIENUU				N/A	Shared Landing?	N/A		,	
	B	PROW/ADA:		N/A	Gutter Ponding?	N/A	N/A	Gutter Slope (%)	N/A
A	11	Not Found, R304.5.1, R304.2.2		N/A	Gutter Lip Ht (in)	N/A	N/A	Gutter X Slope (%)	N/A
		Not Found, K304.5.1, K304.2.2		N/A	Painted X Walk1?	No	N/A	Painted X Walk2?	No
and the line				N/A	X Walk 1 Direction	To S		X Walk 2 Direction	To E
	-11 1. 6.			N/A	X Walk 1 Width (in)	N/A	N/A	X Walk 2 Width (in)	N/A
Street 1 Name WENTWATER ST				N/A		5.5	IN/A		5.3
	_				X Walk 1 Slope (%)	5.5 3.8		X Walk 2 Slope (%)	5.3 5.1
Stop Condition-Street 2 Street 2 Name	StopSign CHEVIOTT HILL LN			N/A	X Walk 1 X Slope (%) Ramp inside XWalk1?	3.8 N/A	N/A	X Walk 2 X Slope (%) Ramp inside XWalk2?	5.1 N/A
				N/A	•			•	
Stop Condition-Street 1	None				Road Slope (%)	1.4	N/A	Clear Space?	N/A

Road X Slope (%)	6.1	N/A	Clear Space to XWalk (in)	N/A
				N/A	Any Obstructions?	N/A	N/A	Storm Grate/Utility Hazard?	N/A
		Total Cost: \$ 32	200.00		Obstruction Type			Storm Grate/Utility Type	
						N/A			N/A
