Access Compliance Report

Public Rights-of-Way

(Curb Ramps)

Intersection ID: 46492	Main Street: SHOPTON_RD_WEST	Cross Street: CASTLECOVE_RD	Location: S
ADA ID: FB0E40B77B7E	Ramp Type: PerpDiag	Initial Pass/Fail: Fail	Overall Compliance: No
Severity Score: 22.5			
Codes/Mitigation Info/Possible Solution		Field Measurements/Component Compliance

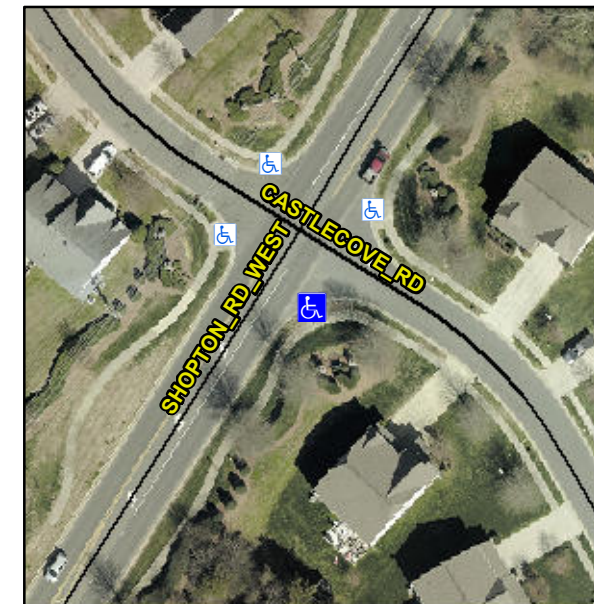
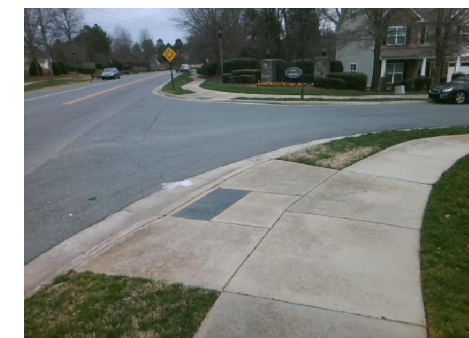
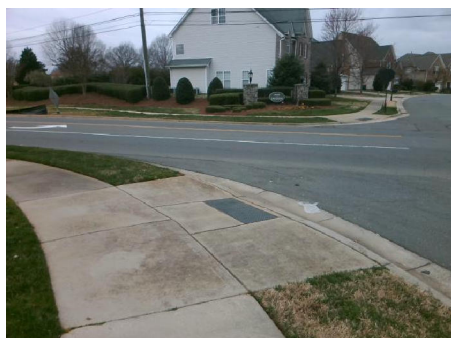
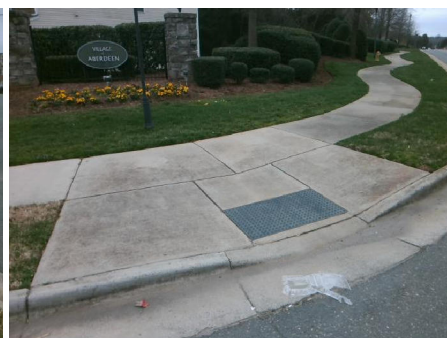
Not Found, R304.5.1, R304.2.2, R304.5.3

Compliance	Description	Data	Compliance	Description	Data
N/A	Ramp Length (in)	60.0	No	Ramp Slope (%)	8.7
No	Ramp Width (in)	46.5	No	Ramp XSlope (%)	4.7
N/A	Flare Type LT	N/A	N/A	Flare Type RT	N/A
N/A	Flare Slope LT (%)	N/A	N/A	Flare Slope RT (%)	N/A
N/A	Flare Traversable LT?	N/A	N/A	Flare Traversable RT?	N/A
N/A	Landing Length (in)	N/A	N/A	DWS Provided?	N/A
N/A	Landing Width (in)	N/A	N/A	DWS Contrast?	N/A
N/A	Landing Slope (%)	N/A	N/A	DWS Length (in)	N/A
N/A	Landing X Slope (%)	N/A	N/A	DWS Full Width?	N/A
N/A	Landing Curb? (Y/N)	N/A	N/A	DWS Offset (in)	N/A
N/A	Shared Landing?	N/A			
N/A	Gutter Ponding?	N/A	N/A	Gutter Slope (%)	N/A
N/A	Gutter Lip Ht (in)	N/A	N/A	Gutter X Slope (%)	N/A
N/A	Painted X Walk1?	No	N/A	Painted X Walk2?	No
	X Walk 1 Direction	To NE		X Walk 2 Direction	To NW
N/A	X Walk 1 Width (in)	N/A	N/A	X Walk 2 Width (in)	N/A
	X Walk 1 Slope (%)	0.5		X Walk 2 Slope (%)	1.0
	X Walk 1 X Slope (%)	2.0		X Walk 2 X Slope (%)	0.4

N/A	Ramp inside XWalk1?	N/A	N/A	Ramp inside XWalk2?	N/A
	Road Slope (%)	0.8	N/A	Clear Space?	N/A
	Road X Slope (%)	2.5	N/A	Clear Space to XWalk (in)	N/A
N/A	Any Obstructions?	N/A	N/A	Storm Grate/Utility Hazard?	N/A
	Obstruction Type			Storm Grate/Utility Type	
		N/A			N/A
			Yes	Surface Condition? (G/P)	Good

Remove & Replace Curb Ramp With Two New Directional Ramps or Equivalent.
