## **Access Compliance Report Public Rights-of-Way** (Curb Ramps)

Intersection ID: 43886 Main Street: ABBOTT ST Cross Street: W\_WORTHINGTON\_AV Location: SW ADA ID: FB41E5595320 Ramp Type: Directional1 Initial Pass/Fail: Fail **Overall Compliance: No Severity Score:** 1.25

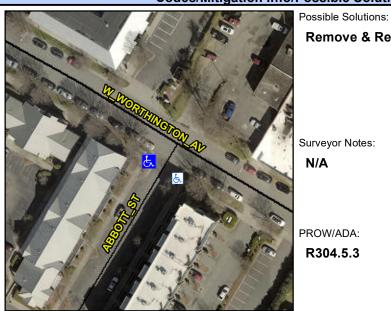
Field Measurements/Component Compliance							
Compliance Description			Data	Compliance		Description	Data
N	I/A	Ramp Length (in)	68.0	N/A	Grad	e Break?	N/A
Υ	'es	Ramp Width (in)	70.0	N/A	Grad	e Break Slope (%)	0.0
Υ	es	Ramp Slope (%)	1.3	N/A	Grad	e Break XSlope (%)	0.0
N	lo	Ramp XSlope (%)	2.2				
N	I/A	Flare Type LT	N/A	N/A	Flare	Type RT	N/A
N	I/A	Flare Slope LT (%)	N/A	N/A	Flare	Slope RT (%)	0.0
N	I/A	Flare Traversable LT?	N/A	N/A	Flare	Traversable RT?	N/A
N	I/A	Landing Length (in)	0.0	N/A	DWS	Provided?	N/A
N	I/A	Landing Width (in)	0.0	N/A	DWS	Contrast?	N/A
N	I/A	Landing Slope (%)	0.0	N/A	DWS	Length (in)	N/A
N	I/A	Landing X Slope (%)	0.0	N/A	DWS	Full Width?	N/A
N	I/A	Landing Curb? (Y/N)	N/A	N/A	DWS	Offset LT (in)	N/A
N	I/A	Shared Landing?	N/A	N/A	DWS	Offset RT (in)	N/A
N	I/A	Gutter Ponding?	0.0	N/A	Gutte	er Slope (%)	N/A
١	I/A	Gutter Lip Ht (in)	0.0	N/A	Gutte	er X Slope (%)	N/A
N	I/A	Painted X Walk1?	No		Road	Slope (%)	2.0

X Walk 1 Direction	To SE		Road	X Slope (%)	3.
		X Walk 1 Width (in)	N/A		Clear	Space?	N/A
		X Walk 1 Slope (%)	2.6	N/A	Clear	Space to XWalk (in)	N/A
		X Walk 1 X Slope (%)	3.1	N/A	Storn	n Grate/Utility Hazard?	N/A
N	I/A	Ramp inside XWalk1?	N/A		Storn	n Grate/Utility Type	
Ν	I/A	Any Obstructions?	N/A				N/A
		Obstruction Type		Yes	Surfa	ce Condition? (G/P)	Good
			N/A	N/A	Curb	Slope (%)	3.8

Remove & Replace Entire Ramp. Surveyor Notes: N/A PROW/ADA: R304.5.3
