## **Access Compliance Report Public Rights-of-Way** (Curb Ramps)

Intersection ID: 52784 Main Street: SARDIS HALL CT **Cross Street: SARDIS RD** Location: NW

ADA ID: FB474EA92E1F Ramp Type: PerpDiag Initial Pass/Fail: Fail **Overall Compliance: No** Severity Score: 33.75

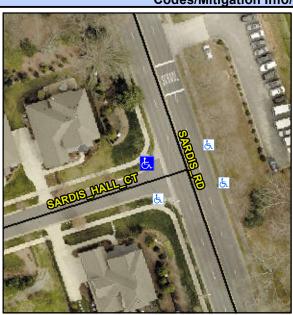
Field Measurements/Component Compliance						
	Compliance Description		Data	Comp	liance Description	Data
	N/A	Ramp Length (in)	96.0	Yes	Ramp Slope (%)	7.3
	No	Ramp Width (in)	46.0	No	Ramp XSlope (%)	7.3
	N/A	Flare Type LT	N/A	N/A	Flare Type RT	N/A
	N/A	Flare Slope LT (%)	N/A	N/A	Flare Slope RT (%)	N/A
	N/A	Flare Traversable LT?	N/A	N/A	Flare Traversable RT?	N/A
	N/A	Landing Length (in)	N/A	N/A	DWS Provided?	N/A
	N/A	Landing Width (in)	N/A	N/A	DWS Contrast?	N/A
	N/A	Landing Slope (%)	N/A	N/A	DWS Length (in)	N/A
	N/A	Landing X Slope (%)	N/A	N/A	DWS Full Width?	N/A
	N/A	Landing Curb? (Y/N)	N/A	N/A	DWS Offset (in)	N/A
	N/A	Shared Landing?	N/A			
	N/A	Gutter Ponding?	N/A	N/A	Gutter Slope (%)	N/A
	N/A	Gutter Lip Ht (in)	N/A	N/A	Gutter X Slope (%)	N/A
	N/A	Painted X Walk1?	No	N/A	Painted X Walk2?	No
		X Walk 1 Direction	To S		X Walk 2 Direction	To E
	N/A	X Walk 1 Width (in)	N/A	N/A	X Walk 2 Width (in)	N/A
		X Walk 1 Slope (%)	0.1		X Walk 2 Slope (%)	4.2

X Walk 1 X Slope (%)	6.2		X Walk 2 X Slope (%)	1.8
	N/A	Ramp inside XWalk1?	N/A	N/A	Ramp inside XWalk2?	N/A
		Road Slope (%)	5.8	N/A	Clear Space?	N/A
		Road X Slope (%)	2.4	N/A	Clear Space to XWalk (in)	N/A
	N/A	Any Obstructions?	N/A	N/A	Storm Grate/Utility Hazard?	N/A
		Obstruction Type			Storm Grate/Utility Type	
			N/A			N/A
				Yes	Surface Condition? (G/P)	Good
7 5	TOTAL TOTAL	MALEN JOHNSON

Possible Solutions: Remove & Replace Curb Ramp With **Two New Directional Ramps or** Equivalent. Surveyor Notes: N/A PROW/ADA: Not Found, R304.5.1, R304.5.3
