Access Compliance Report

Public Rights-of-Way (Curb Ramps)

Intersection ID: 10039625	Main Street: THORNTON_RD	Cross Street: N/A	Location: NW
ADA ID: FB491CDE1F14	Ramp Type: BlendTrans1	Initial Pass/Fail: Pass	Overall Compliance: No
		Severity Score: 0	
Codes/Mitigation Info/Possible Solution		Field Measurements/Component Compliance

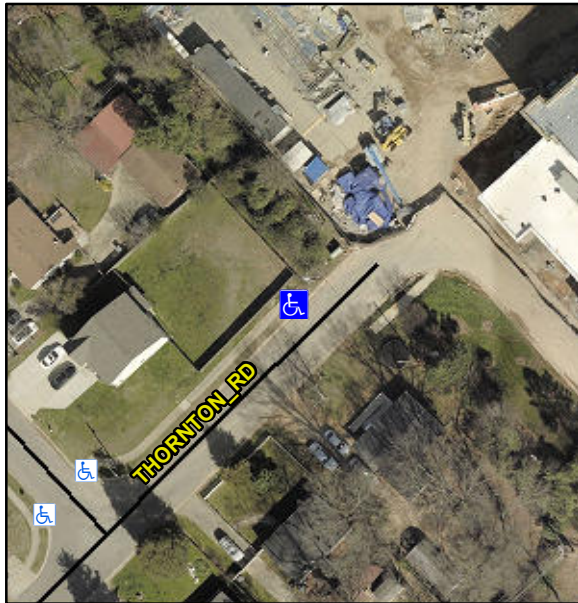
Not Found, R304.5.3

Compliance	Description	Data	Compliance	Description	Data
N/A	Ramp Length (in)	48.0	Yes	BlendTrans Slope (%)	4.7
Yes	Ramp Width (in)	48.0	Yes	BlendTrans XSlope (%)	1.9
N/A	Flare Type LT	Sloped	N/A	Flare Type RT	Sloped
N/A	Flare Slope LT (%)	1.2	N/A	Flare Slope RT (%)	7.9
N/A	Flare Traversable LT?	No	N/A	Flare Traversable RT?	No
Yes	Landing Length (in)	60.0	Yes	DWS Provided?	Yes
Yes	Landing Width (in)	48.0	Yes	DWS Contrast?	Yes
Yes	Landing Slope (%)	1.7	Yes	DWS Length (in)	24.0
Yes	Landing X Slope (%)	1.5	Yes	DWS Full Width?	Yes
N/A	Landing Curb? (Y/N)	No	Yes	DWS Offset (in)	0.0
N/A	Shared Landing?	No			
Yes	Gutter Ponding?	No	Yes	Gutter Slope (%)	0.7
Yes	Gutter Lip Ht (in)	0.0	No	Gutter X Slope (%)	2.4
N/A	Painted X Walk1?	No	N/A	Painted X Walk2?	N/A
	X Walk 1 Direction	To SE		X Walk 2 Direction	N/A
	X Walk 1 Width (in)	N/A		X Walk 2 Width (in)	N/A
	X Walk 1 Slope (%)	4.2		X Walk 2 Slope (%)	N/A
	X Walk 1 X Slope (%)	1.1		X Walk 2 X Slope (%)	N/A

N/A	Ramp inside XWalk1?	N/A	N/A	Ramp inside XWalk2?	N/A
	Road Slope (%)	1.1		Clear Space?	Yes
	Road X Slope (%)	4.2	N/A	Clear Space to XWalk (in)	N/A
Yes	Any Obstructions?	No	Yes	Storm Grate/Utility Hazard?	No
	Obstruction Type			Storm Grate/Utility Type	
		N/A			N/A
			Yes	Surface Condition? (G/P)	Good
			No	Curb Slope (%)	10.2

Remove & Replace Curb Slope and Extend Ramp. Remove & Replace Gutter.
