Access Compliance Report

Public Rights-of-Way

(Curb Ramps)

Intersection ID: 3742	Main Street: GALLOWAY_RD	Cross Street: TRADITION_VIEW_DR	Location: E
ADA ID: FB4A98720EF4	Ramp Type: Perp	Initial Pass/Fail: Fail	Overall Compliance: No
Severity Score: 10			
Codes/Mitigation Info/Possible Solution		Field Measurements/Component Compliance

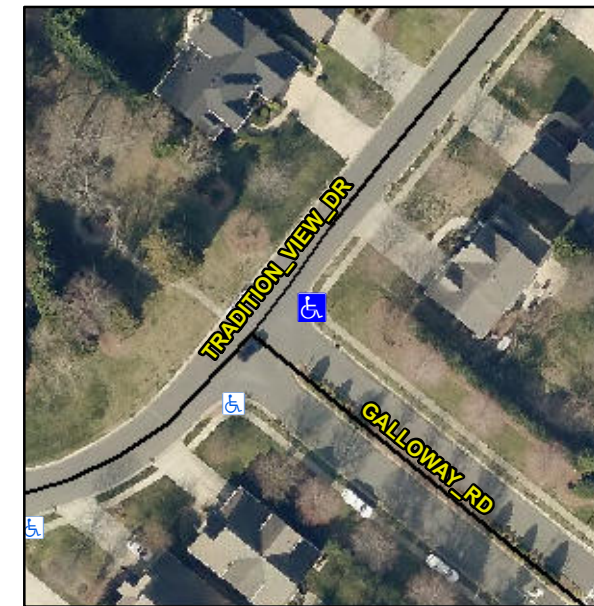
Not Found, R304.5.1, R304.5.3

Compliance	Description	Data	Compliance	Description	Data
N/A	Ramp Length (in)	47.0	Yes	Ramp Slope (%)	5.5
No	Ramp Width (in)	45.5	No	Ramp XSlope (%)	2.8
N/A	Flare Type LT	N/A	N/A	Flare Type RT	N/A
N/A	Flare Slope LT (%)	N/A	N/A	Flare Slope RT (%)	N/A
N/A	Flare Traversable LT?	N/A	N/A	Flare Traversable RT?	N/A
N/A	Landing Length (in)	N/A	N/A	DWS Provided?	N/A
N/A	Landing Width (in)	N/A	N/A	DWS Contrast?	N/A
N/A	Landing Slope (%)	N/A	N/A	DWS Length (in)	N/A
N/A	Landing X Slope (%)	N/A	N/A	DWS Full Width?	N/A
N/A	Landing Curb? (Y/N)	N/A	N/A	DWS Offset (in)	N/A
N/A	Shared Landing?	N/A			
N/A	Gutter Ponding?	N/A	N/A	Gutter Slope (%)	N/A
N/A	Gutter Lip Ht (in)	1.0	N/A	Gutter X Slope (%)	N/A
N/A	Painted X Walk1?	No	N/A	Painted X Walk2?	N/A
	X Walk 1 Direction	To SW		X Walk 2 Direction	N/A
N/A	X Walk 1 Width (in)	N/A	N/A	X Walk 2 Width (in)	N/A
	X Walk 1 Slope (%)	5.1		X Walk 2 Slope (%)	N/A
	X Walk 1 X Slope (%)	0.9		X Walk 2 X Slope (%)	N/A

N/A	Ramp inside XWalk1?	N/A	N/A	Ramp inside XWalk2?	N/A
	Road Slope (%)	N/A	N/A	Clear Space?	N/A
	Road X Slope (%)	N/A	N/A	Clear Space to XWalk (in)	N/A
N/A	Any Obstructions?	N/A	N/A	Storm Grate/Utility Hazard?	N/A
	Obstruction Type			Storm Grate/Utility Type	
		N/A			N/A
			Yes	Surface Condition? (G/P)	Good

Possible Solutions:

Remove & Replace Entire Ramp.
