# Access Compliance Report

## Public Rights-of-Way

### (Curb Ramps)

Intersection ID: 15280	Main Street: DILWORTH_RD_EAST	Cross Street: DILWORTH_RD_WEST	Location: NE
ADA ID: FB503D75D7CD	Ramp Type: PerpDiag	Initial Pass/Fail: Fail	Overall Compliance: No
Severity Score: 26.25			
Codes/Mitigation Info/Possible Solution		Field Measurements/Component Compliance

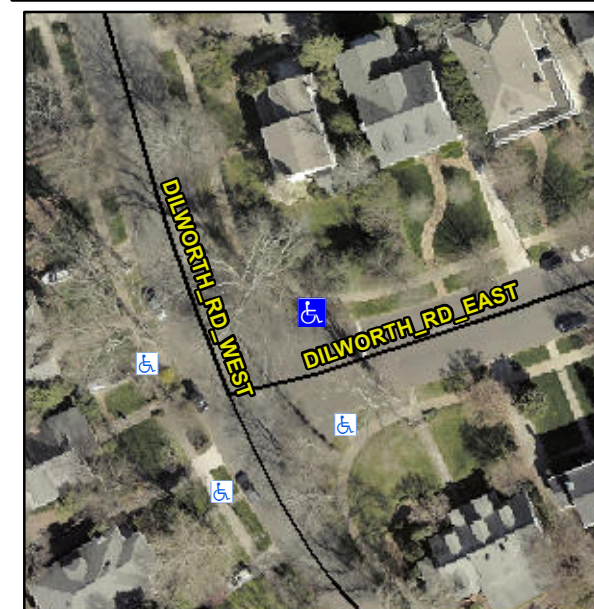
**Not Found, R304.2.2, R304.5.3**

Compliance	Description	Data	Compliance	Description	Data
N/A	Ramp Length (in)	103.0	No	Ramp Slope (%)	13.6
Yes	Ramp Width (in)	60.0	No	Ramp XSlope (%)	3.2
N/A	Flare Type LT	N/A	N/A	Flare Type RT	N/A
N/A	Flare Slope LT (%)	N/A	N/A	Flare Slope RT (%)	N/A
N/A	Flare Traversable LT?	N/A	N/A	Flare Traversable RT?	N/A
N/A	Landing Length (in)	N/A	N/A	DWS Provided?	N/A
N/A	Landing Width (in)	N/A	N/A	DWS Contrast?	N/A
N/A	Landing Slope (%)	N/A	N/A	DWS Length (in)	N/A
N/A	Landing X Slope (%)	N/A	N/A	DWS Full Width?	N/A
N/A	Landing Curb? (Y/N)	N/A	N/A	DWS Offset (in)	N/A
N/A	Shared Landing?	N/A			
N/A	Gutter Ponding?	N/A	N/A	Gutter Slope (%)	N/A
N/A	Gutter Lip Ht (in)	N/A	N/A	Gutter X Slope (%)	N/A
N/A	Painted X Walk1?	No	N/A	Painted X Walk2?	No
	X Walk 1 Direction	To W		X Walk 2 Direction	To S
N/A	X Walk 1 Width (in)	N/A	N/A	X Walk 2 Width (in)	N/A
	X Walk 1 Slope (%)	1.8		X Walk 2 Slope (%)	4.8
	X Walk 1 X Slope (%)	2.1		X Walk 2 X Slope (%)	2.8

N/A	Ramp inside XWalk1?	N/A	N/A	Ramp inside XWalk2?	N/A
	Road Slope (%)	2.2	N/A	Clear Space?	N/A
	Road X Slope (%)	4.8	N/A	Clear Space to XWalk (in)	N/A
N/A	Any Obstructions?	N/A	N/A	Storm Grate/Utility Hazard?	N/A
	Obstruction Type			Storm Grate/Utility Type	
		N/A			N/A
		Yes		Surface Condition? (G/P)	Good

Possible Solutions:

**Remove & Replace Curb Ramp With Two New Directional Ramps or Equivalent.**
