## Access Compliance Report Public Rights-of-Way (Curb Ramps)

Intersection ID: N/A Main Street: E\_3RD\_ST Cross Street: S\_COLLEGE\_ST Location: N

ADA ID: FB589AEA29AC Ramp Type: PerpDiag Initial Pass/Fail: Fail Overall Compliance: No Severity Score: 25

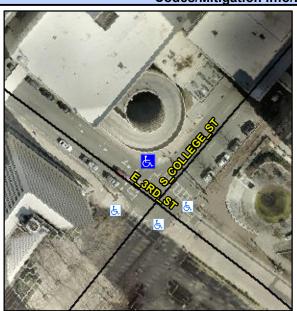
E 3RD ST Signal S COLLEGE ST Signal Possible Solutions:

Not Found, R304.2.2, R304.5.3

Compliance Description		Data	Compliance		Description	Data
N/A	Ramp Length (in)	61.0	No	Ramp	Slope (%)	9.1
Yes	Ramp Width (in)	48.0	No	Ramp	XSlope (%)	5.6
N/A	Flare Type LT	N/A	N/A	Flare	Type RT	N/A
N/A	Flare Slope LT (%)	N/A	N/A	Flare	Slope RT (%)	N/A
N/A	Flare Traversable LT?	N/A	N/A	Flare	Traversable RT?	N/A
N/A	Landing Length (in)	N/A	N/A	DWS	Provided?	N/A
N/A	Landing Width (in)	N/A	N/A	DWS	Contrast?	N/A
N/A	Landing Slope (%)	N/A	N/A	DWS	Length (in)	N/A
N/A	Landing X Slope (%)	N/A	N/A	DWS	Full Width?	N/A
N/A	Landing Curb? (Y/N)	N/A	N/A	DWS	Offset (in)	N/A
N/A	Shared Landing?	N/A				
N/A	Gutter Ponding?	N/A	N/A	Gutte	r Slope (%)	N/A
N/A	Gutter Lip Ht (in)	N/A	N/A	Gutte	r X Slope (%)	N/A
N/A	Painted X Walk1?	Yes	N/A	Paint	ed X Walk2?	Yes
	X Walk 1 Direction	To SW		X Wa	lk 2 Direction	To SE
N/A	X Walk 1 Width (in)	107.0	N/A	X Wa	lk 2 Width (in)	107.0
	X Walk 1 Slope (%)	0.8		X Wa	lk 2 Slope (%)	1.9
	X Walk 1 X Slope (%)	0.7		X Wa	lk 2 X Slope (%)	0.4

N/A	Ramp inside XWalk1?	Yes	N/A	Ram	inside XWalk2?	Yes
	Road Slope (%)	1.7	N/A	Clear	Space?	N/A
	Road X Slope (%)	0.5	N/A	Clear	Space to XWalk (in)	N/A
N/A	Any Obstructions?	N/A	N/A	Storn	n Grate/Utility Hazard?	N/A
	Obstruction Type		l	Storn	n Grate/Utility Type	
		N/A				N/A

Remove & Replace Curb Ramp With
Two New Directional Ramps or
Equivalent.
