Access Compliance Report

Public Rights-of-Way (Curb Ramps)

Intersection ID: 46206	Main Street: LOROPETALUM_RD	Cross Street: SNOWBELL_CT	Location: SE
ADA ID: FB5CB211C87E	Ramp Type: PerpDiag	Initial Pass/Fail: Fail	Overall Compliance: No
Severity Score: 21.25			
Codes/Mitigation Info/Possible Solution		Field Measurements/Component Compliance

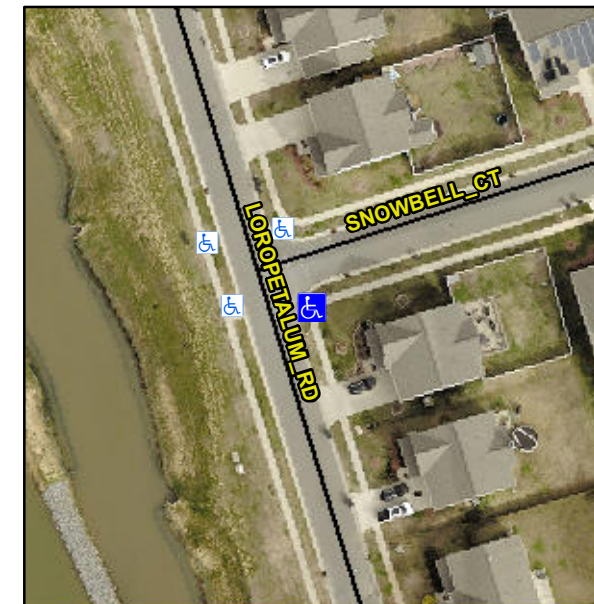
Not Found, R304.5.1, R304.2.2

Compliance	Description	Data	Compliance	Description	Data
N/A	Ramp Length (in)	72.5	No	Ramp Slope (%)	9.4
No	Ramp Width (in)	47.5	Yes	Ramp XSlope (%)	0.4
N/A	Flare Type LT	N/A	N/A	Flare Type RT	N/A
N/A	Flare Slope LT (%)	N/A	N/A	Flare Slope RT (%)	N/A
N/A	Flare Traversable LT?	N/A	N/A	Flare Traversable RT?	N/A
N/A	Landing Length (in)	N/A	N/A	DWS Provided?	N/A
N/A	Landing Width (in)	N/A	N/A	DWS Contrast?	N/A
N/A	Landing Slope (%)	N/A	N/A	DWS Length (in)	N/A
N/A	Landing X Slope (%)	N/A	N/A	DWS Full Width?	N/A
N/A	Landing Curb? (Y/N)	N/A	N/A	DWS Offset (in)	N/A
N/A	Shared Landing?	N/A			
N/A	Gutter Ponding?	N/A	N/A	Gutter Slope (%)	N/A
N/A	Gutter Lip Ht (in)	2.0	N/A	Gutter X Slope (%)	N/A
N/A	Painted X Walk1?	No	N/A	Painted X Walk2?	No
	X Walk 1 Direction	To N		X Walk 2 Direction	To SE
N/A	X Walk 1 Width (in)	N/A	N/A	X Walk 2 Width (in)	N/A
	X Walk 1 Slope (%)	2.7		X Walk 2 Slope (%)	1.3
	X Walk 1 X Slope (%)	3.9		X Walk 2 X Slope (%)	0.7

Remove & Replace Curb Ramp With Two New Directional Ramps or Equivalent.

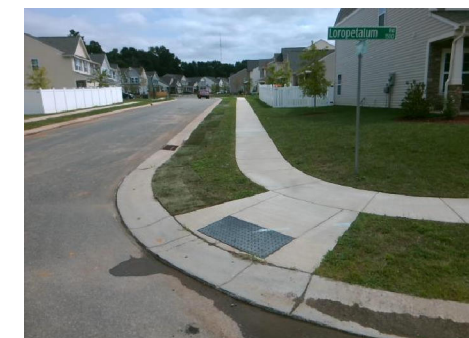
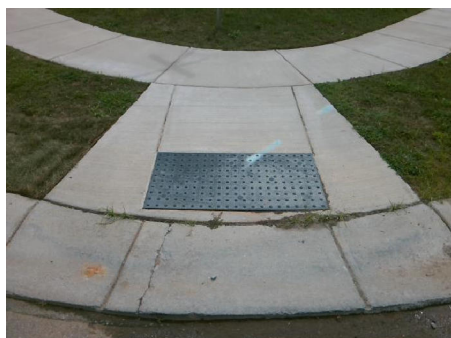
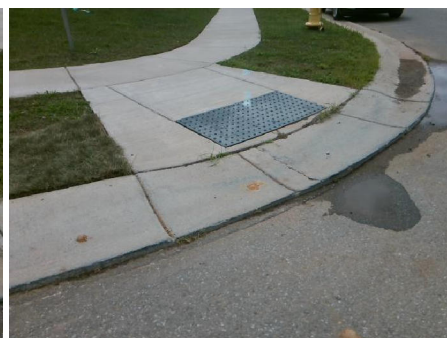
N/A	Ramp inside XWalk1?	N/A	N/A	Ramp inside XWalk2?	N/A
	Road Slope (%)	0.1	N/A	Clear Space?	N/A
	Road X Slope (%)	2.1	N/A	Clear Space to XWalk (in)	N/A
N/A	Any Obstructions?	N/A	N/A	Storm Grate/Utility Hazard?	N/A
	Obstruction Type			Storm Grate/Utility Type	
		N/A			N/A
			Yes	Surface Condition? (G/P)	Good
