# Access Compliance Report

## Public Rights-of-Way

### (Curb Ramps)

Intersection ID: 27595	Main Street: BALLANTYNE COMMONS PY	Cross Street: BALLANTYNE MEADOWS DR	Location: NW
ADA ID: FB5E79B850B6	Ramp Type: Perp	Initial Pass/Fail: Fail	Overall Compliance: No
Severity Score: 22.5			
Codes/Mitigation Info/Possible Solution		Field Measurements/Component Compliance

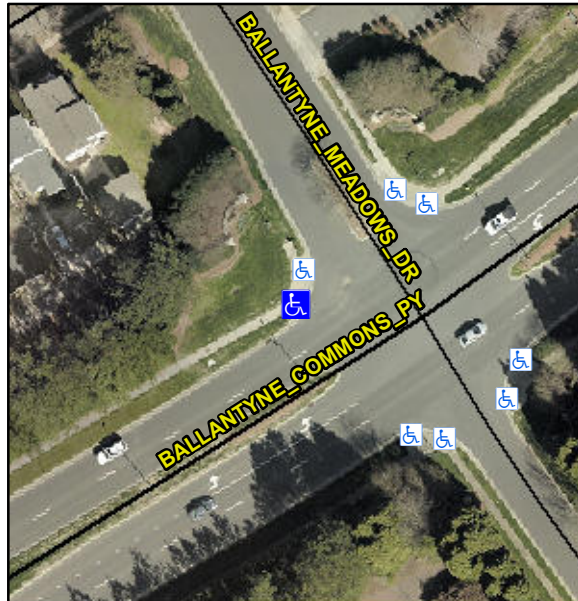
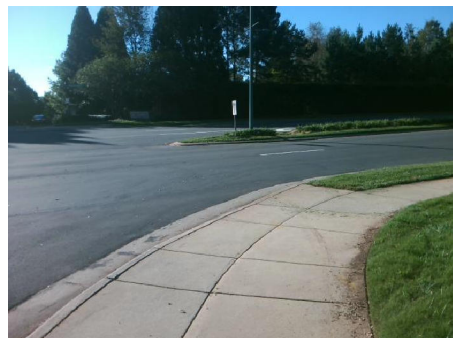
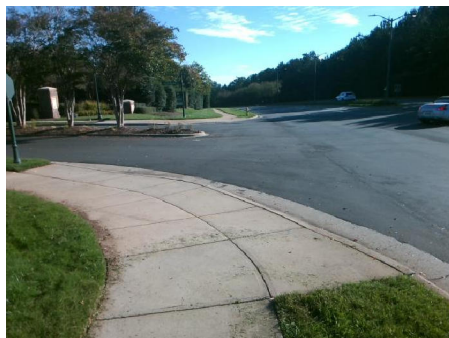
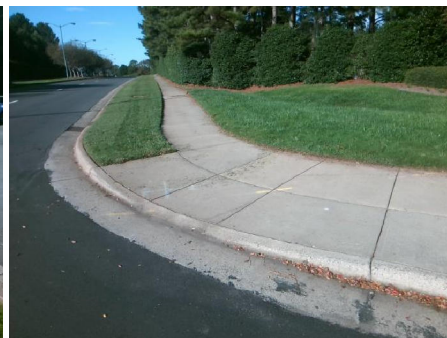
**Not Found, R304.5.1, R304.2.2, R304.5.3**

Compliance	Description	Data	Compliance	Description	Data
N/A	Ramp Length (in)	108.0	No	Ramp Slope (%)	8.4
No	Ramp Width (in)	39.0	No	Ramp XSlope (%)	3.2
N/A	Flare Type LT	N/A	N/A	Flare Type RT	N/A
N/A	Flare Slope LT (%)	N/A	N/A	Flare Slope RT (%)	N/A
N/A	Flare Traversable LT?	N/A	N/A	Flare Traversable RT?	N/A
N/A	Landing Length (in)	N/A	N/A	DWS Provided?	N/A
N/A	Landing Width (in)	N/A	N/A	DWS Contrast?	N/A
N/A	Landing Slope (%)	N/A	N/A	DWS Length (in)	N/A
N/A	Landing X Slope (%)	N/A	N/A	DWS Full Width?	N/A
N/A	Landing Curb? (Y/N)	N/A	N/A	DWS Offset (in)	N/A
N/A	Shared Landing?	N/A			
N/A	Gutter Ponding?	N/A	N/A	Gutter Slope (%)	N/A
N/A	Gutter Lip Ht (in)	N/A	N/A	Gutter X Slope (%)	N/A
N/A	Painted X Walk1?	No	N/A	Painted X Walk2?	N/A
	X Walk 1 Direction	To SE		X Walk 2 Direction	N/A
N/A	X Walk 1 Width (in)	N/A	N/A	X Walk 2 Width (in)	N/A
	X Walk 1 Slope (%)	0.7		X Walk 2 Slope (%)	N/A
	X Walk 1 X Slope (%)	2.4		X Walk 2 X Slope (%)	N/A

N/A	Ramp inside XWalk1?	N/A	N/A	Ramp inside XWalk2?	N/A
	Road Slope (%)	N/A	N/A	Clear Space?	N/A
	Road X Slope (%)	N/A	N/A	Clear Space to XWalk (in)	N/A
N/A	Any Obstructions?	N/A	N/A	Storm Grate/Utility Hazard?	N/A
	Obstruction Type			Storm Grate/Utility Type	
		N/A			N/A
			Yes	Surface Condition? (G/P)	Good

Possible Solutions:

**Remove & Replace Entire Ramp.**
