Access Compliance Report

Public Rights-of-Way

(Curb Ramps)

| Intersection ID: 50608 | Main Street: DENBUR_DR | Cross Street: DOWNY_BIRCH_RD | Location: NW |

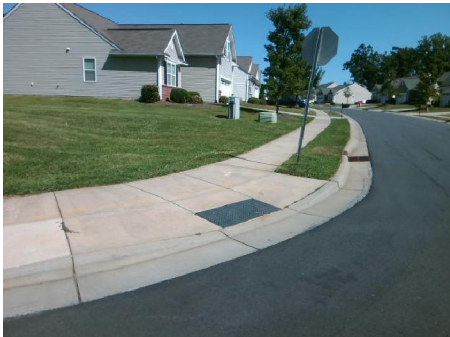
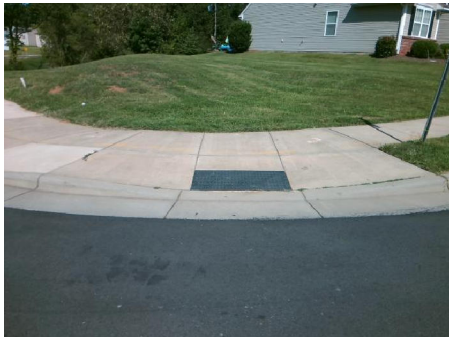
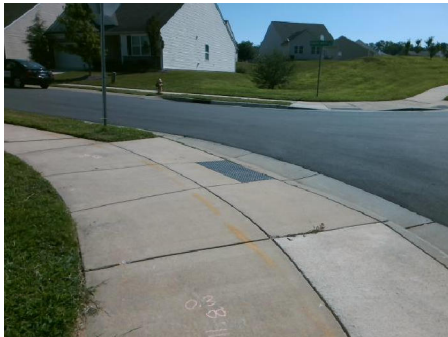
| ADA ID: FB6844329054 | Ramp Type: Combination2 | Initial Pass/Fail: Fail | Overall Compliance: No |
| | | | Severity Score: 13.75 |

| Codes/Mitigation Info/Possible Solution | | | Field Measurements/Component Compliance | | | |
|---|---|--|---|---|---|---|
| <p>Surveyor Notes:</p> <p>LT RP < 5%</p> <p>PROW/ADA:</p> <p>Not Found, R304.5.3, R304.3.2</p> | | | N/A | Flare Type LT | N/A | N/A |

| Codes/Mitigation Info/Possible Solution | | | Field Measurements/Component Compliance | | | |
|---|---|--|---|---|---|---|
| | Remove & Replace Entire Ramp. | | Description | | | Description |
| <p>Total Cost:</p> <p>\$ 1600.00</p> | | | N/A | DWS Contrast? | N/A | N/A |
