Access Compliance Report Public Rights-of-Way (Curb Ramps)

Intersection ID: 10023487 Main Street: CIRCUMFERENTIAL RD **Cross Street: N/A** Location: **ADA ID: FB68743CE8D9** Ramp Type: Perp Initial Pass/Fail: Fail **Overall Compliance: No** Severity Score: 13.75

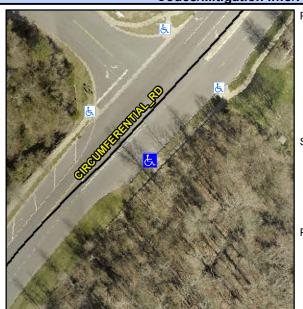
Field Measurements/Component Compliance						
Compliance Description		Data	Comp	liance Des	scription	Data
N/A	Ramp Length (in)	49.0	No	Ramp Slo	pe (%)	9.2
Yes	Ramp Width (in)	53.0	Yes	/es Ramp XSlope (%)		3.6
N/A	Flare Type LT	N/A	N/A	I/A Flare Type RT		N/A
N/A	Flare Slope LT (%)	N/A	N/A	N/A Flare Slope RT (%)		N/A
N/A	Flare Traversable LT?	N/A	N/A	I/A Flare Traversable RT?		N/A
N/A	Landing Length (in)	N/A	N/A	DWS Prov	vided?	N/A
N/A	Landing Width (in)	N/A	N/A	DWS Con	trast?	N/A
N/A	Landing Slope (%)	N/A	N/A	DWS Len	gth (in)	N/A
N/A	Landing X Slope (%)	N/A	N/A	DWS Full	Width?	N/A
N/A	Landing Curb? (Y/N)	N/A	N/A	DWS Offs	et (in)	N/A
N/A	Shared Landing?	N/A				
N/A	Gutter Ponding?	N/A	N/A	Gutter Slo	ppe (%)	N/A
N/A	Gutter Lip Ht (in)	N/A	N/A	Gutter X S	Slope (%)	N/A
N/A	Painted X Walk1?	No	N/A	Painted X	Walk2?	N/A
	X Walk 1 Direction	To NW		X Walk 2	Direction	N/A
N/A	X Walk 1 Width (in)	N/A	N/A	X Walk 2	Width (in)	N/A

X Walk 1 Slope (%)	2.5		X Walk 2	Slope (%)	N/A
	X Walk 1 X Slope (%)	3.9		X Walk 2	X Slope (%)	N/A
N/A	Ramp inside XWalk1?	N/A	N/A	Ramp ins	ide XWalk2?	N/A
	Road Slope (%)	N/A	N/A	Clear Spa	ce?	N/A
	Road X Slope (%)	N/A	N/A	Clear Spa	ce to XWalk (in)	N/A
N/A	Any Obstructions?	N/A	N/A	Storm Gra	ate/Utility Hazard?	N/A
	Obstruction Type			Storm Gra	ate/Utility Type	
		N/A				N/A
			Yes	Surface C	ondition? (G/P)	Good

CIRCUMFERENTIAL RD Street 1 Name Stop Condition-Street 2 None Street 2 Name N/A Stop Condition-Street 1 N/A Possible Solutions: Remove & Replace Entire Ramp. Surveyor Notes: N/A PROW/ADA: Not Found, R304.2.2
