Access Compliance Report

Public Rights-of-Way

(Curb Ramps)

Intersection ID: 2741	Main Street: CHRISTENBURY_RD	Cross Street: MILLSTREAM_RIDGE_DR	Location: SE
ADA ID: FB6D8F10F3CF	Ramp Type: BlendTrans1	Initial Pass/Fail: Fail	Overall Compliance: No
Severity Score: 10			
Codes/Mitigation Info/Possible Solution		Field Measurements/Component Compliance

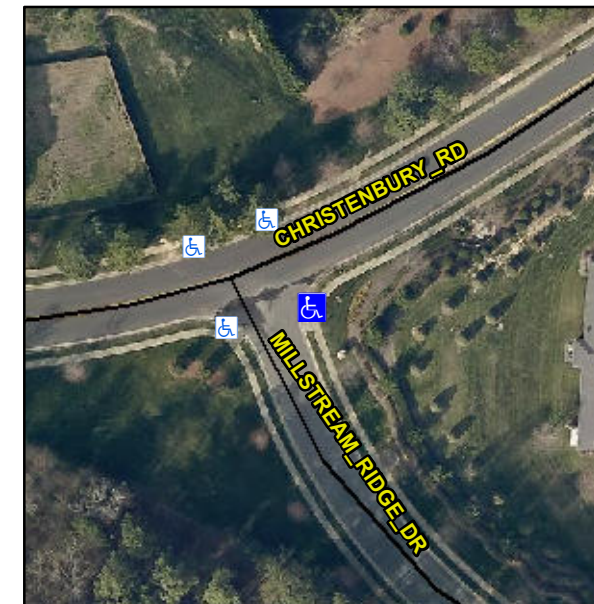
R304.5.1, R304.5.3

Compliance	Description	Data	Compliance	Description	Data
N/A	Ramp Length (in)	47.0	Yes	BlendTrans Slope (%)	1.5
No	Ramp Width (in)	42.0	No	BlendTrans XSlope (%)	4.5
N/A	Flare Type LT	N/A	N/A	Flare Type RT	N/A
N/A	Flare Slope LT (%)	N/A	N/A	Flare Slope RT (%)	N/A
N/A	Flare Traversable LT?	N/A	N/A	Flare Traversable RT?	N/A
N/A	Landing Length (in)	N/A	N/A	DWS Provided?	N/A
N/A	Landing Width (in)	N/A	N/A	DWS Contrast?	N/A
N/A	Landing Slope (%)	N/A	N/A	DWS Length (in)	N/A
N/A	Landing X Slope (%)	N/A	N/A	DWS Full Width?	N/A
N/A	Landing Curb? (Y/N)	N/A	N/A	DWS Offset (in)	N/A
N/A	Shared Landing?	N/A			
N/A	Gutter Ponding?	N/A	N/A	Gutter Slope (%)	N/A
N/A	Gutter Lip Ht (in)	N/A	N/A	Gutter X Slope (%)	N/A
N/A	Painted X Walk1?	No	N/A	Painted X Walk2?	No
	X Walk 1 Direction	To NW		X Walk 2 Direction	To W
	X Walk 1 Width (in)	N/A		X Walk 2 Width (in)	N/A
	X Walk 1 Slope (%)	5.1		X Walk 2 Slope (%)	1.5
	X Walk 1 X Slope (%)	1.5		X Walk 2 X Slope (%)	0.8

N/A	Ramp inside XWalk1?	N/A	N/A	Ramp inside XWalk2?	N/A
	Road Slope (%)	4.7		Clear Space?	N/A
	Road X Slope (%)	2.1	N/A	Clear Space to XWalk (in)	N/A
N/A	Any Obstructions?	N/A	N/A	Storm Grate/Utility Hazard?	N/A
	Obstruction Type			Storm Grate/Utility Type	
		N/A			N/A
			Yes	Surface Condition? (G/P)	Good
			N/A	Curb Slope (%)	N/A

Remove & Replace Curb Ramp With Two New Directional Ramps or Equivalent.

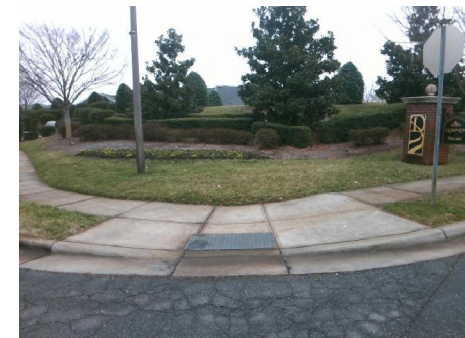
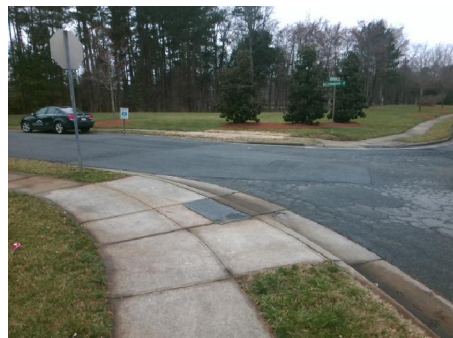
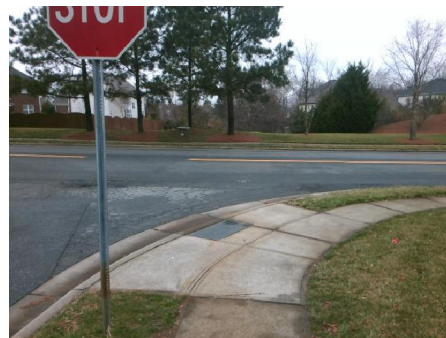
Street 1 Name CHRISTENBURY RD

Stop Condition-Street 1 None

Street 2 Name MILLSTREAM RIDGE DR

Stop Condition-Street 2 StopSign
