Intersection ID: 16898	Main Street: FLINTRIDGE_DR	Cross Street: IDLEWILD_RD	Location:	SE
ADA ID: FB935FDF3771	Ramp Type: PerpDiag	Initial Pass/Fail: Fail	Overall Compliance: No	Severity Score: 13.75

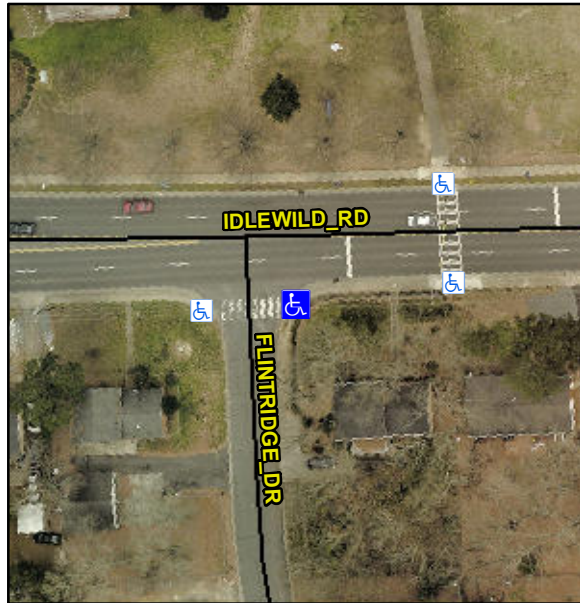
R304.2.2, R304.5.3

Compliance	Description	Data	Compliance	Description	Data
N/A	Ramp Length (in)	60.0	No	Ramp Slope (%)	10.6
Yes	Ramp Width (in)	48.0	No	Ramp XSlope (%)	4.9
N/A	Flare Type LT	N/A	N/A	Flare Type RT	N/A
N/A	Flare Slope LT (%)	N/A	N/A	Flare Slope RT (%)	N/A
N/A	Flare Traversable LT?	N/A	N/A	Flare Traversable RT?	N/A
N/A	Landing Length (in)	N/A	N/A	DWS Provided?	N/A
N/A	Landing Width (in)	N/A	N/A	DWS Contrast?	N/A
N/A	Landing Slope (%)	N/A	N/A	DWS Length (in)	N/A
N/A	Landing X Slope (%)	N/A	N/A	DWS Full Width?	N/A
N/A	Landing Curb? (Y/N)	N/A	N/A	DWS Offset (in)	N/A
N/A	Shared Landing?	N/A			
N/A	Gutter Ponding?	N/A	N/A	Gutter Slope (%)	N/A
N/A	Gutter Lip Ht (in)	N/A	N/A	Gutter X Slope (%)	N/A
N/A	Painted X Walk1?	No	N/A	Painted X Walk2?	Yes
	X Walk 1 Direction	To N		X Walk 2 Direction	To W
N/A	X Walk 1 Width (in)	N/A	N/A	X Walk 2 Width (in)	124.0
	X Walk 1 Slope (%)	0.8		X Walk 2 Slope (%)	0.8
	X Walk 1 X Slope (%)	4.5		X Walk 2 X Slope (%)	6.8

N/A	Ramp inside XWalk1?	N/A	N/A	Ramp inside XWalk2?	Yes
	Road Slope (%)	4.8	N/A	Clear Space?	N/A
	Road X Slope (%)	0.7	N/A	Clear Space to XWalk (in)	N/A
N/A	Any Obstructions?	N/A	N/A	Storm Grate/Utility Hazard?	N/A
	Obstruction Type			Storm Grate/Utility Type	
		N/A			N/A
			Yes	Surface Condition? (G/P)	Good

Remove & Replace Curb Ramp With Two New Directional Ramps or Equivalent.
