# Access Compliance Report

## Public Rights-of-Way

| Intersection ID: 26408 | Main Street: BEVINGTON_PL | Cross Street: PEMBRY_LINKS_CR | Location: SE |
| ADA ID: FBA685DD160B | Ramp Type: BlendTrans2 | Initial Pass/Fail: Fail | Overall Compliance: No |

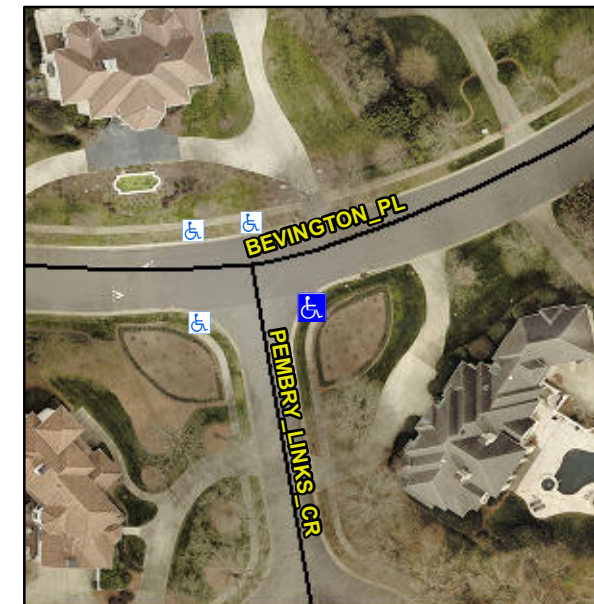
| Severity Score: 30 | | | |

**Not Found, R304.5.1, R304.5.3**

| Compliance | Description | Data | Compliance | Description | Data |
|---|---|---|---|---|---|
| No | Ramp Width (in) | 34.0 | No | BlendTrans XSlope (%) | 5.6 |
| | | | No | Curb Slope (%) | 12.4 |

**Remove & Replace Curb Ramp With Two New Directional Ramps or Equivalent.**
