Access Compliance Report

Public Rights-of-Way

(Curb Ramps)

Intersection ID: N/A	Main Street: LUTHER_ST	Cross Street: QUEENS_RD	Location: NW
ADA ID: FBB1FD91E2E8	Ramp Type: Perp	Initial Pass/Fail: Fail	Overall Compliance: No
Severity Score: 35			
Codes/Mitigation Info/Possible Solution		Field Measurements/Component Compliance

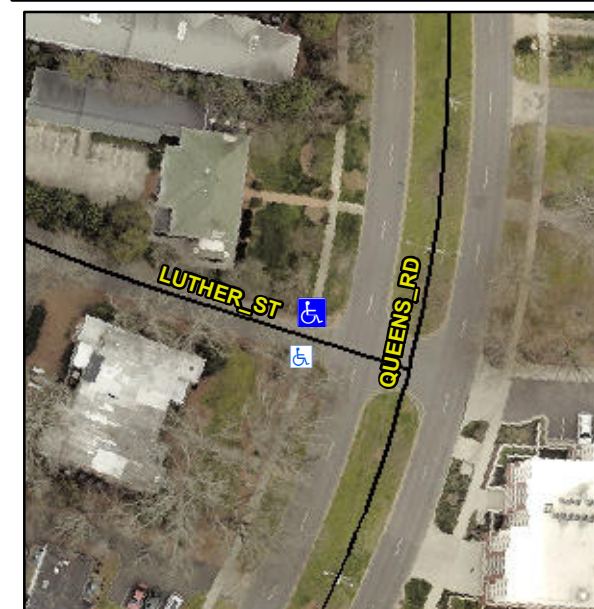
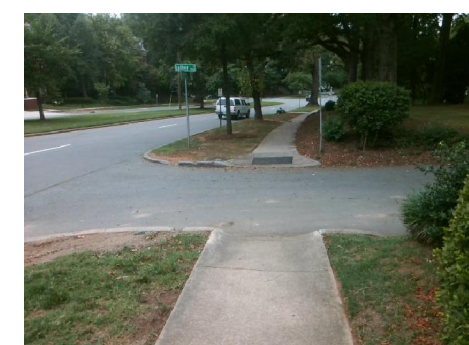
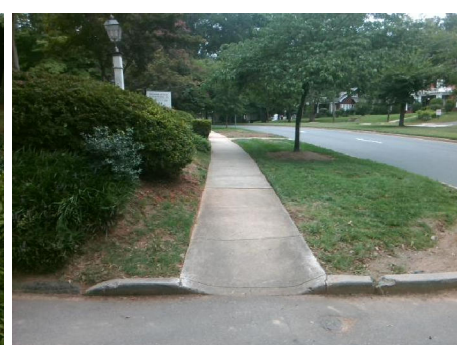
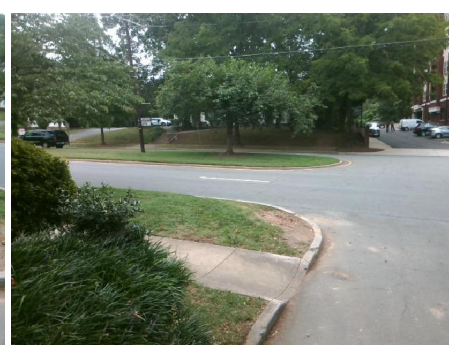
Not Found, R304.5.1, R304.2.2, R304.5.3

Compliance	Description	Data	Compliance	Description	Data
N/A	Ramp Length (in)	43.0	No	Ramp Slope (%)	15.2
No	Ramp Width (in)	36.0	No	Ramp XSlope (%)	3.7
N/A	Flare Type LT	N/A	N/A	Flare Type RT	N/A
N/A	Flare Slope LT (%)	N/A	N/A	Flare Slope RT (%)	N/A
N/A	Flare Traversable LT?	N/A	N/A	Flare Traversable RT?	N/A
N/A	Landing Length (in)	N/A	N/A	DWS Provided?	N/A
N/A	Landing Width (in)	N/A	N/A	DWS Contrast?	N/A
N/A	Landing Slope (%)	N/A	N/A	DWS Length (in)	N/A
N/A	Landing X Slope (%)	N/A	N/A	DWS Full Width?	N/A
N/A	Landing Curb? (Y/N)	N/A	N/A	DWS Offset (in)	N/A
N/A	Shared Landing?	N/A			
N/A	Gutter Ponding?	N/A	N/A	Gutter Slope (%)	N/A
N/A	Gutter Lip Ht (in)	N/A	N/A	Gutter X Slope (%)	N/A
N/A	Painted X Walk1?	No	N/A	Painted X Walk2?	N/A
	X Walk 1 Direction	To SW		X Walk 2 Direction	N/A
N/A	X Walk 1 Width (in)	N/A	N/A	X Walk 2 Width (in)	N/A
	X Walk 1 Slope (%)	2.1		X Walk 2 Slope (%)	N/A
	X Walk 1 X Slope (%)	3.2		X Walk 2 X Slope (%)	N/A

N/A	Ramp inside XWalk1?	N/A	N/A	Ramp inside XWalk2?	N/A
	Road Slope (%)	N/A	N/A	Clear Space?	N/A
	Road X Slope (%)	N/A	N/A	Clear Space to XWalk (in)	N/A
N/A	Any Obstructions?	N/A	N/A	Storm Grate/Utility Hazard?	N/A
	Obstruction Type			Storm Grate/Utility Type	
		N/A			N/A
			Yes	Surface Condition? (G/P)	Good

Possible Solutions:

Remove & Replace Entire Ramp.
