Access Compliance Report

Public Rights-of-Way

(Curb Ramps)

Intersection ID: 24782	Main Street: BLACK_DUCK_CT	Cross Street: CANVASBACK_DR	Location: S
ADA ID: FBB5A66B8340	Ramp Type: PerpDiag	Initial Pass/Fail: Fail	Overall Compliance: No
Codes/Mitigation Info/Possible Solution		Field Measurements/Component Compliance

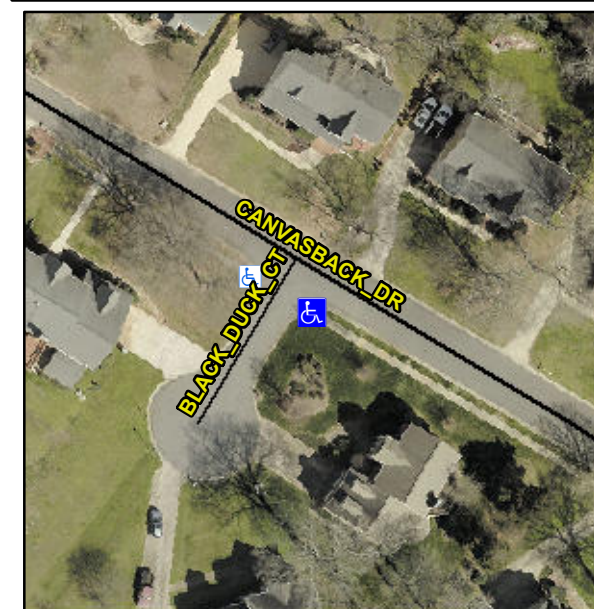
Not Found, R304.5.1, R304.5.3

Compliance	Description	Data	Compliance	Description	Data
N/A	Ramp Length (in)	40.0	Yes	Ramp Slope (%)	6.5
No	Ramp Width (in)	47.5	No	Ramp XSlope (%)	5.2
N/A	Flare Type LT	N/A	N/A	Flare Type RT	N/A
N/A	Flare Slope LT (%)	N/A	N/A	Flare Slope RT (%)	N/A
N/A	Flare Traversable LT?	N/A	N/A	Flare Traversable RT?	N/A
N/A	Landing Length (in)	N/A	N/A	DWS Provided?	N/A
N/A	Landing Width (in)	N/A	N/A	DWS Contrast?	N/A
N/A	Landing Slope (%)	N/A	N/A	DWS Length (in)	N/A
N/A	Landing X Slope (%)	N/A	N/A	DWS Full Width?	N/A
N/A	Landing Curb? (Y/N)	N/A	N/A	DWS Offset (in)	N/A
N/A	Shared Landing?	N/A			
N/A	Gutter Ponding?	N/A	N/A	Gutter Slope (%)	N/A
N/A	Gutter Lip Ht (in)	N/A	N/A	Gutter X Slope (%)	N/A
N/A	Painted X Walk1?	No	N/A	Painted X Walk2?	No
	X Walk 1 Direction	To NE		X Walk 2 Direction	To NW
N/A	X Walk 1 Width (in)	N/A	N/A	X Walk 2 Width (in)	N/A
	X Walk 1 Slope (%)	7.5		X Walk 2 Slope (%)	3.9
	X Walk 1 X Slope (%)	1.1		X Walk 2 X Slope (%)	5.7

N/A	Ramp inside XWalk1?	N/A	N/A	Ramp inside XWalk2?	N/A
	Road Slope (%)	4.0	N/A	Clear Space?	N/A
	Road X Slope (%)	6.6	N/A	Clear Space to XWalk (in)	N/A
N/A	Any Obstructions?	N/A	N/A	Storm Grate/Utility Hazard?	N/A
	Obstruction Type			Storm Grate/Utility Type	
		N/A			N/A
			Yes	Surface Condition? (G/P)	Good

Possible Solutions:

Remove & Replace Curb Ramp With Two New Directional Ramps or Equivalent.
