Access Compliance Report Public Rights-of-Way (Curb Ramps)

Intersection ID: N/A Main Street: ARBOR LOOP DR **Cross Street: POTOMAC RIVER PY** Location: NW ADA ID: FBBE630659C4 Ramp Type: Directional2 Initial Pass/Fail: Fail **Overall Compliance: No Severity Score:** 1.25

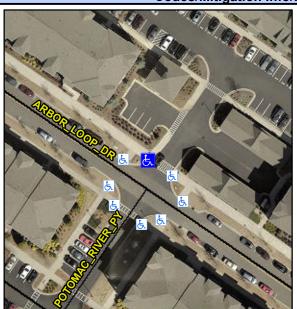
Comp	liance Description	Data	Comp	liance	Description	Data
N/A	Ramp Length (in)	78.0	N/A	Grade	Break?	N/A
Yes	Ramp Width (in)	117.0	N/A	Grade	e Break Slope (%)	0.0
Yes	Ramp Slope (%)	0.7	N/A	Grade	e Break XSlope (%)	0.0
No	Ramp XSlope (%)	2.7				
N/A	Flare Type LT	N/A	N/A	Flare	Type RT	N/A
N/A	Flare Slope LT (%)	N/A	N/A	Flare	Slope RT (%)	0.0
N/A	Flare Traversable LT?	N/A	N/A	Flare	Traversable RT?	N/A
N/A	Landing Length (in)	0.0	N/A	DWS	Provided?	N/A
N/A	Landing Width (in)	0.0	N/A	DWS	Contrast?	N/A
N/A	Landing Slope (%)	0.0	N/A	DWS	Length (in)	N/A
N/A	Landing X Slope (%)	0.0	N/A	DWS	Full Width?	N/A
N/A	Landing Curb? (Y/N)	N/A	N/A	DWS	Offset LT (in)	N/A
N/A	Shared Landing?	N/A	N/A	DWS	Offset RT (in)	N/A
N/A	Gutter Ponding?	0.0	N/A	Gutte	r Slope (%)	N/A
N/A	Gutter Lip Ht (in)	0.0	N/A	Gutte	r X Slope (%)	N/A
N/A	Painted X Walk1?	Yes		Road	Slope (%)	0.9
	X Walk 1 Direction	To E		Road	X Slope (%)	3.0
	X Walk 1 Width (in)	118.0		Clear	Space?	N/A

X Walk 1 Slope (%)	0.9	N/A	Clear	Space to XWalk (in)	N/A
	X Walk 1 X Slope (%)	3.0	N/A	Storm	Grate/Utility Hazard?	N/A
N/A	Ramp inside XWalk1?	Yes		Storm	Grate/Utility Type	
N/A	Any Obstructions?	N/A				N/A
	Obstruction Type		Yes	Surfa	ce Condition? (G/P)	Good
		N/A	N/A	Curb	Slope (%)	0.6

Possible Solutions: Remove & Replace Entire Ramp. Surveyor Notes: N/A PROW/ADA: R304.5.3
