# Access Compliance Report

## Public Rights-of-Way

| Intersection ID: 2891 | Main Street: BEAROAK_LN | Cross Street: RIDGEFIELD_DR | Location: W |
| ADA ID: FBBF803A89AA | Ramp Type: PerpDiag | Initial Pass/Fail: Fail | Overall Compliance: No |

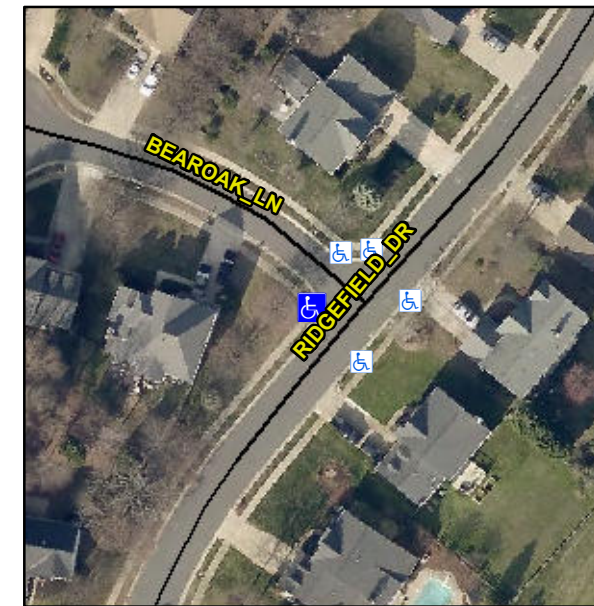
**Not Found, R304.5.1, R304.2.2, R304.5.3**

| Compliance | Description | Data | Compliance | Description | Data |
|---|---|---|---|---|---|
| N/A | Ramp Length (in) | 52.0 | No | Ramp Slope (%) | 8.7 |
| No | Ramp Width (in) | 41.0 | No | Ramp XSlope (%) | 6.1 |

**Remove & Replace Curb Ramp With Two New Directional Ramps or Equivalent.**
