Intersection ID: 15865	Main Street: ST_JAMES_PL	Cross Street: STANCILL_PL	Location:	SW
ADA ID: FBC11F0EF363	Ramp Type: PerpDiag	Initial Pass/Fail: Fail	Overall Compliance: No	Severity Score: 18.75

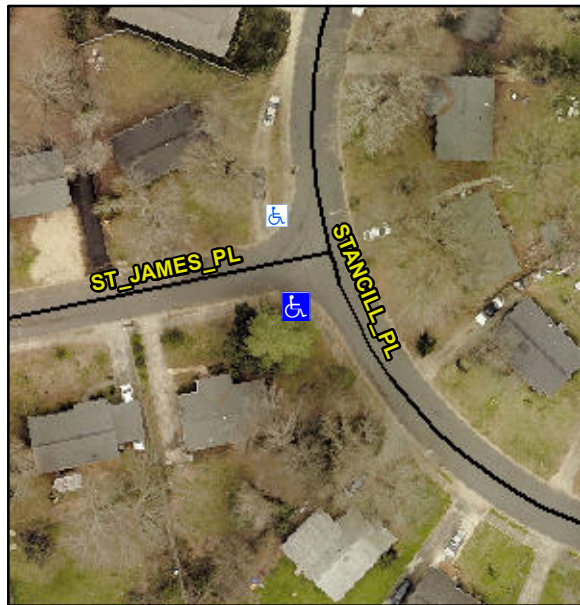
**Not Found, R304.5.1, R304.5.3**

Compliance	Description	Data	Compliance	Description	Data
N/A	Ramp Length (in)	76.0	Yes	Ramp Slope (%)	6.8
No	Ramp Width (in)	35.0	No	Ramp XSlope (%)	4.6
N/A	Flare Type LT	N/A	N/A	Flare Type RT	N/A
N/A	Flare Slope LT (%)	N/A	N/A	Flare Slope RT (%)	N/A
N/A	Flare Traversable LT?	N/A	N/A	Flare Traversable RT?	N/A
N/A	Landing Length (in)	N/A	N/A	DWS Provided?	N/A
N/A	Landing Width (in)	N/A	N/A	DWS Contrast?	N/A
N/A	Landing Slope (%)	N/A	N/A	DWS Length (in)	N/A
N/A	Landing X Slope (%)	N/A	N/A	DWS Full Width?	N/A
N/A	Landing Curb? (Y/N)	N/A	N/A	DWS Offset (in)	N/A
N/A	Shared Landing?	N/A			
N/A	Gutter Ponding?	N/A	N/A	Gutter Slope (%)	N/A
N/A	Gutter Lip Ht (in)	N/A	N/A	Gutter X Slope (%)	N/A
N/A	Painted X Walk1?	No	N/A	Painted X Walk2?	No
	X Walk 1 Direction	To E		X Walk 2 Direction	To N
N/A	X Walk 1 Width (in)	N/A	N/A	X Walk 2 Width (in)	N/A
	X Walk 1 Slope (%)	0.2		X Walk 2 Slope (%)	7.3
	X Walk 1 X Slope (%)	4.6		X Walk 2 X Slope (%)	0.1

N/A	Ramp inside XWalk1?	N/A	N/A	Ramp inside XWalk2?	N/A
	Road Slope (%)	3.0	N/A	Clear Space?	N/A
	Road X Slope (%)	7.5	N/A	Clear Space to XWalk (in)	N/A
N/A	Any Obstructions?	N/A	N/A	Storm Grate/Utility Hazard?	N/A
	Obstruction Type			Storm Grate/Utility Type	
		N/A			N/A
			Yes	Surface Condition? (G/P)	Good

### Possible Solutions:

**Remove & Replace Curb Ramp With Two New Directional Ramps or Equivalent.**
