Access Compliance Report

Public Rights-of-Way

(Curb Ramps)

Intersection ID: N/A	Main Street: WALNUT_LOOP_RD	Cross Street: WOODBINE_WALK_RD	Location: NE
ADA ID: FBD1F7E5E179	Ramp Type: Perp	Initial Pass/Fail: Fail	Overall Compliance: No
		Severity Score: 37.5

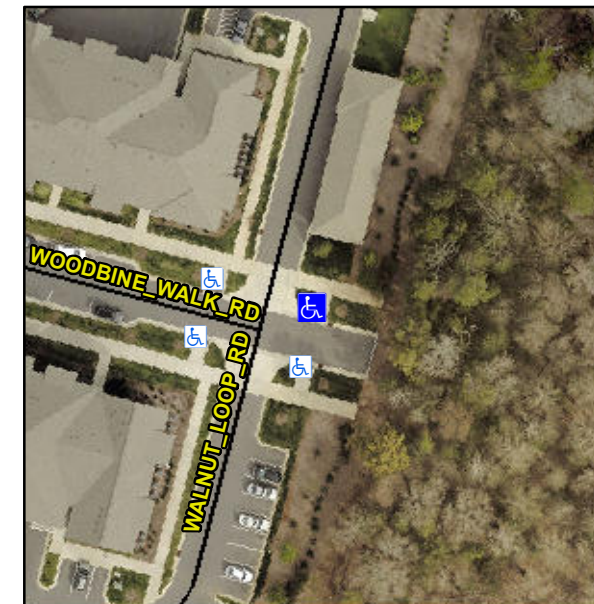
R304.2.2, R304.5.3

Compliance	Description	Data	Compliance	Description	Data
N/A	Ramp Length (in)	80.0	No	Ramp Slope (%)	9.0
Yes	Ramp Width (in)	94.0	No	Ramp XSlope (%)	7.6
N/A	Flare Type LT	N/A	N/A	Flare Type RT	N/A
N/A	Flare Slope LT (%)	N/A	N/A	Flare Slope RT (%)	N/A
N/A	Flare Traversable LT?	N/A	N/A	Flare Traversable RT?	N/A
N/A	Landing Length (in)	N/A	N/A	DWS Provided?	N/A
N/A	Landing Width (in)	N/A	N/A	DWS Contrast?	N/A
N/A	Landing Slope (%)	N/A	N/A	DWS Length (in)	N/A
N/A	Landing X Slope (%)	N/A	N/A	DWS Full Width?	N/A
N/A	Landing Curb? (Y/N)	N/A	N/A	DWS Offset (in)	N/A
N/A	Shared Landing?	N/A			
N/A	Gutter Ponding?	N/A	N/A	Gutter Slope (%)	N/A
N/A	Gutter Lip Ht (in)	N/A	N/A	Gutter X Slope (%)	N/A
N/A	Painted X Walk1?	No	N/A	Painted X Walk2?	N/A
	X Walk 1 Direction	To SW		X Walk 2 Direction	N/A
N/A	X Walk 1 Width (in)	N/A	N/A	X Walk 2 Width (in)	N/A
	X Walk 1 Slope (%)	1.6		X Walk 2 Slope (%)	N/A
	X Walk 1 X Slope (%)	3.3		X Walk 2 X Slope (%)	N/A

Remove & Replace Entire Ramp.

Total Cost: \$ 1850.00
