Access Compliance Report Public Rights-of-Way (Curb Ramps)

· ·		-						
Intersection ID: 21913	Main Street: MEANS_CT			reet:	WESTHALL_DR	Location:	SW			
ADA ID: FC00AD8D7506	Ramp Type: PerpDiag			Initial Pass/Fail: Fail Overall Compliance: No			o Severity Score:	37.5		
Codes/Mitigation Info/Possible Solution				Field Measurements/Component Compliance						
A State of the second s		Possible Solutions:		Compliance Description			Data Compliance Description			
REALS OF	5	Remove & Replace Curb Ramp With Two New Directional Ramps or Equivalent.	/ith	N/A	Ramp Length (in)	60.0	No	Ramp Slope (%)	8.7	
				Yes	Ramp Width (in)	48.0	No	Ramp XSlope (%)	7.9	
			1	N/A	Flare Type LT	N/A	N/A	Flare Type RT	N/A	
				N/A	Flare Slope LT (%)	N/A	N/A	Flare Slope RT (%)	N/A	
				N/A	Flare Traversable LT?	N/A	N/A	Flare Traversable RT?	N/A	
				N/A	Landing Length (in)	N/A	N/A	DWS Provided?	N/A

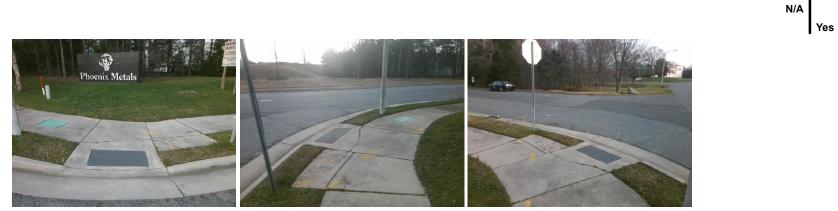
L.		Surveyor Notes:		N/A	Landing Width (in)	N/A	N/A	DWS Contrast?	N/A	
		N/A		N/A	Landing Slope (%)	N/A	N/A	DWS Length (in)	N/A	
				N/A	Landing X Slope (%)	N/A	N/A	DWS Full Width?	N/A	
S AND SE S				N/A	Landing Curb? (Y/N)	N/A	N/A	DWS Offset (in)	N/A	
Martin and		4		N/A	Shared Landing?	N/A		()		
		PROW/ADA:		N/A	Gutter Ponding?	N/A	N/A	Gutter Slope (%)	N/A	
		Not Found, R304.2.2, R304.5.3		N/A	Gutter Lip Ht (in)	N/A	N/A	Gutter X Slope (%)	N/A	
		Not i ouna, Roo4.2.2, Roo4.0.0		N/A	Painted X Walk1?	No	N/A	Painted X Walk2?	No	
a the state of the	C C C C C C C C C C C C C C C C C C C				X Walk 1 Direction	To NE		X Walk 2 Direction	To SE	
			N/A	X Walk 1 Width (in)	N/A	N/A	X Walk 2 Width (in)	N/A		
Street 1 Name	WESTHALL DR	-			X Walk 1 Slope (%)	4.0		X Walk 2 Slope (%)	0.3	
Stop Condition-Street 2	None				X Walk 1 X Slope (%)	0.4		X Walk 2 X Slope (%)	3.7	
Street 2 Name	MEANS CT			N/A	Ramp inside XWalk1?	N/A	N/A	Ramp inside XWalk2?	N/A

Stop Condition-Street 1	StopSign				Road Slope (%)	3.4	N/A	Clear Space?	N/A	
					Road X Slope (%)	3.7	N/A	Clear Space to XWalk (in)	N/A	
				N/A	Any Obstructions?	N/A	N/A	Storm Grate/Utility Hazard?	N/A	
		Total Cost: \$ 32	200.00		Obstruction Type			Storm Grate/Utility Type
