Access Compliance Report Public Rights-of-Way (Curb Ramps)

Intersection ID: N/A Main Street: ROCKWAY DR **Cross Street: CHESTERFIELD AV** Location: SE **Overall Compliance: No Severity Score:** 12.5 **ADA ID: FC028D3CE553** Ramp Type: PerpDiag Initial Pass/Fail: Fail

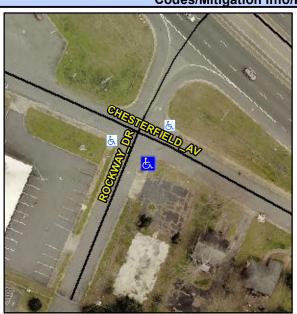
Total Cost: 3200.00 Compliance Description <u>Data</u> Compliance Description Data No N/A Ramp Length (in) 65.0 Ramp Slope (%) 10.5 Yes Ramp XSlope (%) Yes Ramp Width (in) 48.0 0.1 N/A N/A Flare Type LT N/A Flare Type RT N/A N/A N/A N/A Flare Slope RT (%) N/A Flare Slope LT (%) N/A Flare Traversable LT? N/A N/A Flare Traversable RT? N/A N/A N/A N/A **DWS Provided?** N/A Landing Length (in) N/A Landing Width (in) N/A N/A **DWS Contrast?** N/A N/A N/A N/A Landing Slope (%) DWS Length (in) N/A N/A Landing X Slope (%) N/A N/A DWS Full Width? N/A N/A Landing Curb? (Y/N) N/A N/A DWS Offset (in) N/A N/A N/A Shared Landing? N/A **Gutter Ponding?** N/A N/A Gutter Slope (%) N/A N/A Gutter Lip Ht (in) N/A N/A Gutter X Slope (%) N/A N/A Painted X Walk1? No N/A Painted X Walk2? No X Walk 1 Direction To NE X Walk 2 Direction To NW N/A N/A X Walk 1 Width (in) X Walk 2 Width (in) N/A X Walk 1 Slope (%) 4.6 X Walk 2 Slope (%) 2.6 X Walk 1 X Slope (%) 0.3 X Walk 2 X Slope (%) 0.3 N/A N/A N/A Ramp inside XWalk2? N/A Ramp inside XWalk1? Road Slope (%) 1.9 N/A Clear Space? N/A N/A Road X Slope (%) Clear Space to XWalk (in) N/A 1.2 N/A N/A N/A Any Obstructions? Storm Grate/Utility Hazard? N/A

Street 1 Name Stop Condition-Street 2 Street 2 Name Stop Condition-Street 1 **CHESTERFIELD AV** StopSign **ROCKWAY DR** None Possible Solutions: Remove & Replace Curb Ramp With Two New Directional Ramps or Equivalent. Surveyor Notes: N/A PROW/ADA: Not Found, R304.2.2
