Access Compliance Report Public Rights-of-Way (Curb Ramps)

Intersection ID: 10844 Main Street: W_5TH_ST Cross Street: FRAZIER_AV Location: S

ADA ID: FC0487F2C9FC Ramp Type: PerpDiag Initial Pass/Fail: Fail Overall Compliance: No Severity Score: 33.75

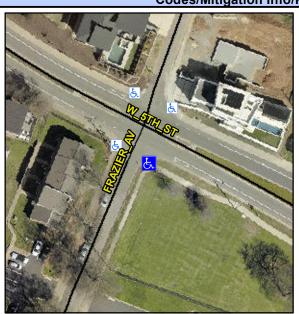
Field Measurements/Component Compliance					
Compliance Description		Data	Compliance Description		Data
N/A	Ramp Length (in)	51.5	Yes	Ramp Slope (%)	6.5
No	Ramp Width (in)	40.5	No	Ramp XSlope (%)	12.7
N/A	Flare Type LT	N/A	N/A	Flare Type RT	N/A
N/A	Flare Slope LT (%)	N/A	N/A	Flare Slope RT (%)	N/A
N/A	Flare Traversable LT?	N/A	N/A	Flare Traversable RT?	N/A
N/A	Landing Length (in)	N/A	N/A	DWS Provided?	N/A
N/A	Landing Width (in)	N/A	N/A	DWS Contrast?	N/A
N/A	Landing Slope (%)	N/A	N/A	DWS Length (in)	N/A
N/A	Landing X Slope (%)	N/A	N/A	DWS Full Width?	N/A
N/A	Landing Curb? (Y/N)	N/A	N/A	DWS Offset (in)	N/A
N/A	Shared Landing?	N/A			
N/A	Gutter Ponding?	N/A	N/A	Gutter Slope (%)	N/A
N/A	Gutter Lip Ht (in)	0.5	N/A	Gutter X Slope (%)	N/A
N/A	Painted X Walk1?	No	N/A	Painted X Walk2?	No
	X Walk 1 Direction	To NE		X Walk 2 Direction	To NW
N/A	X Walk 1 Width (in)	N/A	N/A	X Walk 2 Width (in)	N/A
	X Walk 1 Slope (%)	1.3		X Walk 2 Slope (%)	8.8

X Walk 1 X Slope (%)	10.0		X Walk 2 X Slope (%)	5.4
N/A	Ramp inside XWalk1?	N/A	N/A	Ramp inside XWalk2?	N/A
	Road Slope (%)	6.4	N/A	Clear Space?	N/A
	Road X Slope (%)	9.6	N/A	Clear Space to XWalk (in)	N/A
N/A	Any Obstructions?	N/A	N/A	Storm Grate/Utility Hazard?	N/A
	Obstruction Type			Storm Grate/Utility Type	
		N/A			N/A
			Yes	Surface Condition? (G/P)	Good
3 68

Remove & Replace Curb Ramp With Two New Directional Ramps or Equivalent.

R304.5.1, R304.5.3
