Access Compliance Report

Public Rights-of-Way

(Curb Ramps)

Intersection ID: 45179	Main Street: ELDON_DR	Cross Street: MAPLEHURST_DR	Location: SW
ADA ID: FC11B72912D9	Ramp Type: PerpDiag	Initial Pass/Fail: Pass	Overall Compliance: No
			Severity Score: 15.25

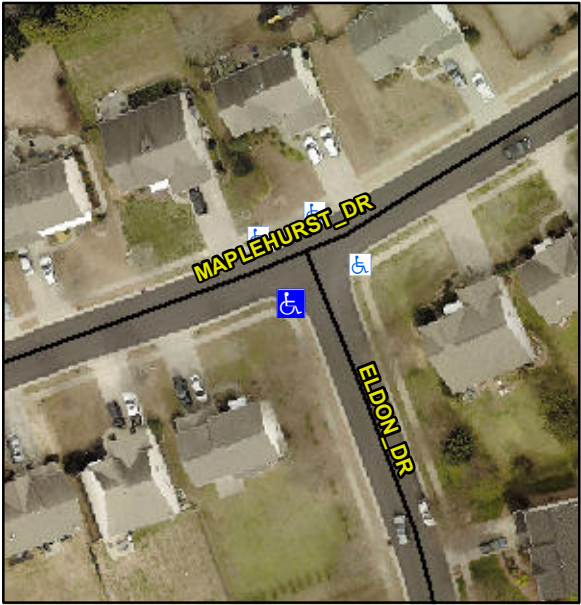
Compliance	Description	Data	Compliance	Description	Data
N/A	Ramp Length (in)	47.0	Yes	Ramp Slope (%)	6.4
Yes	Ramp Width (in)	49.0	No	Ramp XSlope (%)	2.7
N/A	Flare Type LT	Sloped	N/A	Flare Type RT	N/A
N/A	Flare Slope LT (%)	2.5	N/A	Flare Slope RT (%)	3.9
N/A	Flare Traversable LT?	No	N/A	Flare Traversable RT?	No
Yes	Landing Length (in)	48.0	No	DWS Provided?	No
Yes	Landing Width (in)	52.0	N/A	DWS Contrast?	No
No	Landing Slope (%)	3.5	N/A	DWS Length (in)	N/A
Yes	Landing X Slope (%)	0.6	N/A	DWS Full Width?	No
N/A	Landing Curb? (Y/N)	No	N/A	DWS Offset (in)	N/A
N/A	Shared Landing?	No			
Yes	Gutter Ponding?	No	No	Gutter Slope (%)	7.3
Yes	Gutter Lip Ht (in)	0.0	Yes	Gutter X Slope (%)	1.0
N/A	Painted X Walk1?	No	N/A	Painted X Walk2?	No
	X Walk 1 Direction	To NE		X Walk 2 Direction	To N
N/A	X Walk 1 Width (in)	N/A	N/A	X Walk 2 Width (in)	N/A
	X Walk 1 Slope (%)	1.4		X Walk 2 Slope (%)	2.3
	X Walk 1 X Slope (%)	3.3		X Walk 2 X Slope (%)	0.6

N/A	Ramp inside XWalk1?	N/A	N/A	Ramp inside XWalk2?	N/A
	Road Slope (%)	2.0	N/A	Clear Space?	Yes
	Road X Slope (%)	3.1	N/A	Clear Space to XWalk (in)	N/A
Yes	Any Obstructions?	No	Yes	Storm Grate/Utility Hazard?	No
	Obstruction Type			Storm Grate/Utility Type	
		N/A			N/A
			Yes	Surface Condition? (G/P)	Good

Possible Solutions:				
	Remove & Replace Curb Ramp With Two New Directional Ramps or Equivalent. Remove & Replace Gutter.				
	Surveyor Notes:				
	N/A				
	PROW/ADA:				
	Not Found, R304.5.3, R304.2.2-Perp, R304.3.2-Para, R305, R304.5.4				
Street 1 Name	ELDON DR				
Stop Condition-Street 2	StopSign				
Street 2 Name	MAPLEHURST DR				
Stop Condition-Street 1	None				
Total Cost:		\$	3950.00
