Access Compliance Report

Public Rights-of-Way

(Curb Ramps)

Intersection ID: 14831	Main Street: BARFIELD_DR	Cross Street: MANCHESTER_DR	Location: NW
ADA ID: FC29D2D3F24D	Ramp Type: BlendTrans1	Initial Pass/Fail: Fail	Overall Compliance: No
		Severity Score: 42.5

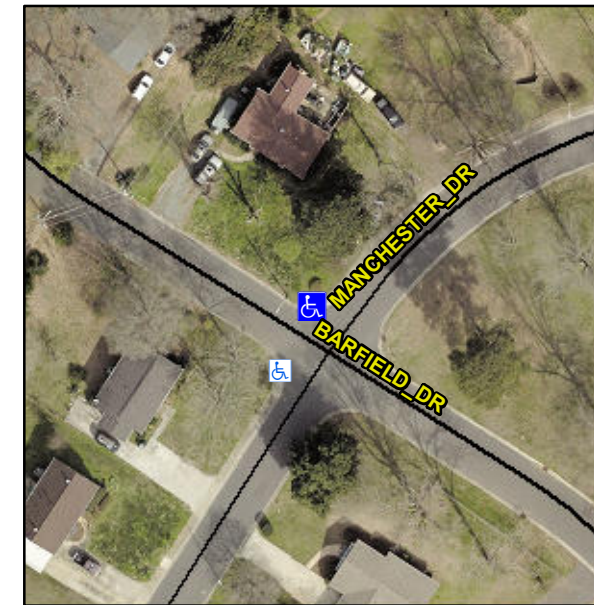
Not Found, R304.5.1, R304.5.3

Compliance	Description	Data	Compliance	Description	Data
N/A	Ramp Length (in)	48.0	Yes	BlendTrans Slope (%)	4.2
No	Ramp Width (in)	35.0	No	BlendTrans XSlope (%)	7.8
N/A	Flare Type LT	N/A	N/A	Flare Type RT	N/A
N/A	Flare Slope LT (%)	N/A	N/A	Flare Slope RT (%)	N/A
N/A	Flare Traversable LT?	N/A	N/A	Flare Traversable RT?	N/A
N/A	Landing Length (in)	N/A	N/A	DWS Provided?	N/A
N/A	Landing Width (in)	N/A	N/A	DWS Contrast?	N/A
N/A	Landing Slope (%)	N/A	N/A	DWS Length (in)	N/A
N/A	Landing X Slope (%)	N/A	N/A	DWS Full Width?	N/A
N/A	Landing Curb? (Y/N)	N/A	N/A	DWS Offset (in)	N/A
N/A	Shared Landing?	N/A			
N/A	Gutter Ponding?	N/A	N/A	Gutter Slope (%)	N/A
N/A	Gutter Lip Ht (in)	N/A	N/A	Gutter X Slope (%)	N/A
N/A	Painted X Walk1?	No	N/A	Painted X Walk2?	No
	X Walk 1 Direction	To SW		X Walk 2 Direction	To SE
	X Walk 1 Width (in)	N/A		X Walk 2 Width (in)	N/A
	X Walk 1 Slope (%)	10.9		X Walk 2 Slope (%)	3.4
	X Walk 1 X Slope (%)	1.4		X Walk 2 X Slope (%)	7.5

N/A	Ramp inside XWalk1?	N/A	N/A	Ramp inside XWalk2?	N/A
	Road Slope (%)	4.5		Clear Space?	N/A
	Road X Slope (%)	8.2	N/A	Clear Space to XWalk (in)	N/A
N/A	Any Obstructions?	N/A	N/A	Storm Grate/Utility Hazard?	N/A
	Obstruction Type			Storm Grate/Utility Type	
		N/A			N/A
			Yes	Surface Condition? (G/P)	Good
			No	Curb Slope (%)	10.6

Remove & Replace Curb Ramp With Two New Directional Ramps or Equivalent.
