# Access Compliance Report

## Public Rights-of-Way

### (Curb Ramps)

Intersection ID: 12998	Main Street: 5TH_ST	Cross Street: MCDOWELL_ST	Location: E
ADA ID: FC2D119BF4E0	Ramp Type: Perp	Initial Pass/Fail: Fail	Overall Compliance: No
Severity Score: 12.5			
Codes/Mitigation Info/Possible Solution		Field Measurements/Component Compliance

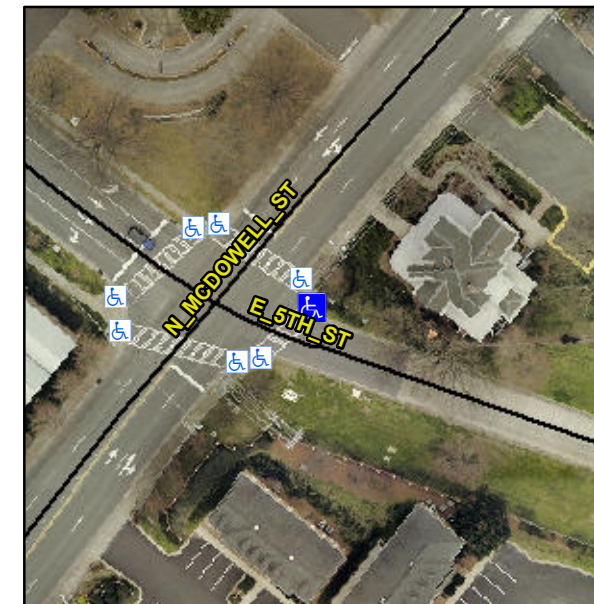
**Not Found, R304.5.3**

Compliance	Description	Data	Compliance	Description	Data
N/A	Ramp Length (in)	72.0	Yes	Ramp Slope (%)	6.4
Yes	Ramp Width (in)	54.0	No	Ramp XSlope (%)	6.0
N/A	Flare Type LT	N/A	N/A	Flare Type RT	N/A
N/A	Flare Slope LT (%)	N/A	N/A	Flare Slope RT (%)	N/A
N/A	Flare Traversable LT?	N/A	N/A	Flare Traversable RT?	N/A
N/A	Landing Length (in)	N/A	N/A	DWS Provided?	N/A
N/A	Landing Width (in)	N/A	N/A	DWS Contrast?	N/A
N/A	Landing Slope (%)	N/A	N/A	DWS Length (in)	N/A
N/A	Landing X Slope (%)	N/A	N/A	DWS Full Width?	N/A
N/A	Landing Curb? (Y/N)	N/A	N/A	DWS Offset (in)	N/A
N/A	Shared Landing?	N/A			
N/A	Gutter Ponding?	N/A	N/A	Gutter Slope (%)	N/A
N/A	Gutter Lip Ht (in)	N/A	N/A	Gutter X Slope (%)	N/A
N/A	Painted X Walk1?	Yes	N/A	Painted X Walk2?	N/A
	X Walk 1 Direction	To SW		X Walk 2 Direction	N/A
N/A	X Walk 1 Width (in)	108.0	N/A	X Walk 2 Width (in)	N/A
	X Walk 1 Slope (%)	1.4		X Walk 2 Slope (%)	N/A
	X Walk 1 X Slope (%)	2.5		X Walk 2 X Slope (%)	N/A

N/A	Ramp inside XWalk1?	Yes	N/A	Ramp inside XWalk2?	N/A
	Road Slope (%)	N/A	N/A	Clear Space?	N/A
	Road X Slope (%)	N/A	N/A	Clear Space to XWalk (in)	N/A
N/A	Any Obstructions?	N/A	N/A	Storm Grate/Utility Hazard?	N/A
	Obstruction Type			Storm Grate/Utility Type	
		N/A			N/A
		Yes		Surface Condition? (G/P)	Good

**Remove & Replace Entire Ramp.**
