Access Compliance Report

Public Rights-of-Way

(Curb Ramps)

Intersection ID: 11066	Main Street: BRIARGROVE_DR	Cross Street: MENDHAM_DR	Location: SW
ADA ID: FC457D17FCF3	Ramp Type: Directional1	Initial Pass/Fail: Pass	Overall Compliance: No
Severity Score: 2.75			
Codes/Mitigation Info/Possible Solution		Field Measurements/Component Compliance

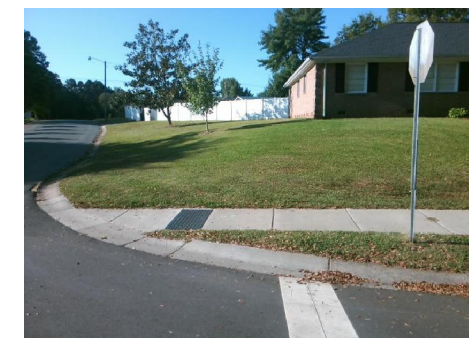
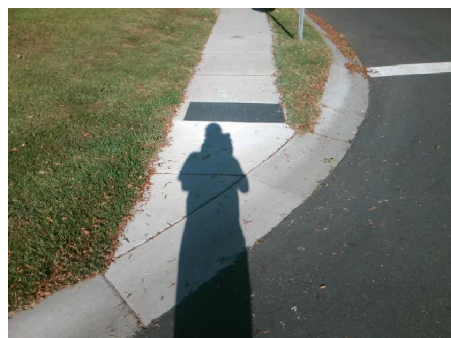
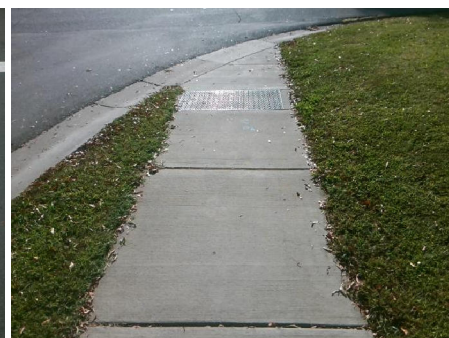
Compliance	Description	Data	Compliance	Description	Data
N/A	Ramp Length (in)	48.5	N/A	Grade Break?	N/A
Yes	Ramp Width (in)	57.0	N/A	Grade Break Slope (%)	0.0
Yes	Ramp Slope (%)	1.1	N/A	Grade Break XSlope (%)	0.0
No	Ramp XSlope (%)	4.0			
N/A	Flare Type LT	N/A	N/A	Flare Type RT	N/A
N/A	Flare Slope LT (%)	N/A	N/A	Flare Slope RT (%)	N/A
N/A	Flare Traversable LT?	N/A	N/A	Flare Traversable RT?	N/A
Yes	Landing Length (in)	55.5	Yes	DWS Provided?	Yes
Yes	Landing Width (in)	60.0	Yes	DWS Contrast?	Yes
Yes	Landing Slope (%)	0.4	Yes	DWS Length (in)	24.0
No	Landing X Slope (%)	3.1	No	DWS Full Width?	No
N/A	Landing Curb? (Y/N)	No	No	DWS Offset LT (in)	82.0
N/A	Shared Landing?	No	No	DWS Offset RT (in)	15.0
Yes	Gutter Ponding?	No	Yes	Gutter Slope (%)	0.5
Yes	Gutter Lip Ht (in)	0.0	No	Gutter X Slope (%)	2.6
N/A	Painted X Walk1?	No		Road Slope (%)	2.2
	X Walk 1 Direction	To SE		Road X Slope (%)	1.8
	X Walk 1 Width (in)	N/A		Clear Space?	Yes

X Walk 1 Slope (%)	2.2	N/A	Clear Space to XWalk (in)	N/A
	X Walk 1 X Slope (%)	1.8	Yes	Storm Grate/Utility Hazard?	No
N/A	Ramp inside XWalk1?	N/A		Storm Grate/Utility Type	
Yes	Any Obstructions?	No			N/A
	Obstruction Type		Yes	Surface Condition? (G/P)	Good
			N/A	Curb Slope (%)	3.0

Possible Solutions:

**Remove & Replace Entire Ramp.
Remove & Replace Gutter.**
