Access Compliance Report Public Rights-of-Way (Curb Ramps)

Intersection ID: 10040201 Main Street: TYVOLA RD **Cross Street: N/A** Location: SW Initial Pass/Fail: Fail ADA ID: FC589B54C7E7 Ramp Type: Perp **Overall Compliance: No Severity Score:** 10

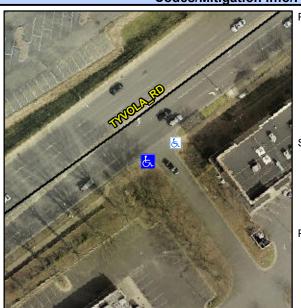
ENTRANCE Street 1 Name Stop Condition-Street 2 StopSign Street 2 Name N/A Stop Condition-Street 1 N/A Possible Solutions: Remove & Replace Entire Ramp. Surveyor Notes: N/A PROW/ADA: Not Found, R304.5.1, R304.5.3

| Field Measurements/Component Compliance Compliance Description Data Compliance Description Data | | | | | |
|--|---|---|---|---|---|
| No | Ramp Width (in) | 47.0 | No | Ramp XSlope (%) | 4.0 |
