Access Compliance Report Public Rights-of-Way (Curb Ramps)

Intersection ID: 10038838	Main Street: STEELECROFT_PY	Cross Street: N/A	Location: N
ADA ID: FC6985B4E6CF	Ramp Type: PerpDiag	Initial Pass/Fail: Fail	Overall Compliance: No Severity Score: 22.5

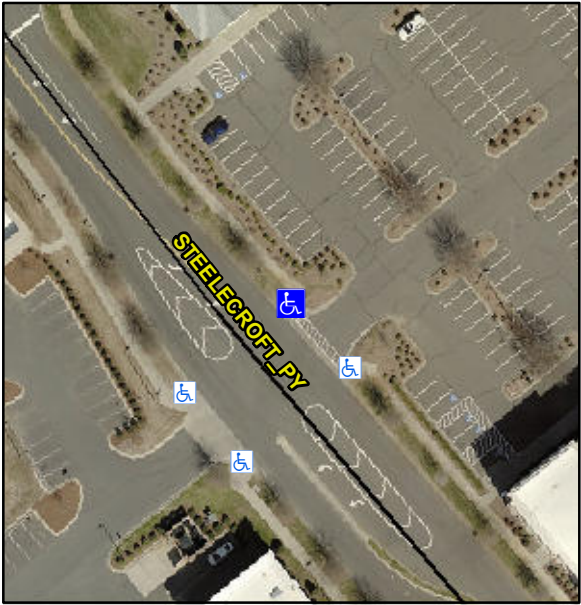
PROW/ADA:
Not Found, R304.5.1, R304.2.2, R304.5.3

Compliance	Description	Data	Compliance	Description	Data
N/A	Ramp Length (in)	102.0	No	Ramp Slope (%)	8.7
No	Ramp Width (in)	38.0	No	Ramp XSlope (%)	3.7
N/A	Flare Type LT	N/A	N/A	Flare Type RT	N/A
N/A	Flare Slope LT (%)	N/A	N/A	Flare Slope RT (%)	N/A
N/A	Flare Traversable LT?	N/A	N/A	Flare Traversable RT?	N/A
N/A	Landing Length (in)	N/A	N/A	DWS Provided?	N/A
N/A	Landing Width (in)	N/A	N/A	DWS Contrast?	N/A
N/A	Landing Slope (%)	N/A	N/A	DWS Length (in)	N/A
N/A	Landing X Slope (%)	N/A	N/A	DWS Full Width?	N/A
N/A	Landing Curb? (Y/N)	N/A	N/A	DWS Offset (in)	N/A
N/A	Shared Landing?	N/A			
N/A	Gutter Ponding?	N/A	N/A	Gutter Slope (%)	N/A
N/A	Gutter Lip Ht (in)	N/A	N/A	Gutter X Slope (%)	N/A
N/A	Painted X Walk1?	No	N/A	Painted X Walk2?	Yes
	X Walk 1 Direction	To E		X Walk 2 Direction	To SE
N/A	X Walk 1 Width (in)	N/A	N/A	X Walk 2 Width (in)	52.0
	X Walk 1 Slope (%)	0.7		X Walk 2 Slope (%)	0.2
	X Walk 1 X Slope (%)	0.6		X Walk 2 X Slope (%)	3.5

N/A	Ramp inside XWalk1?	N/A	N/A	Ramp inside XWalk2?	Yes
	Road Slope (%)	3.0	N/A	Clear Space?	N/A
	Road X Slope (%)	1.8	N/A	Clear Space to XWalk (in)	N/A
N/A	Any Obstructions?	N/A	N/A	Storm Grate/Utility Hazard?	N/A
	Obstruction Type			Storm Grate/Utility Type	
			N/A		N/A
			Yes	Surface Condition? (G/P)	Good

Possible Solutions:
Remove & Replace Curb Ramp With Two New Directional Ramps or Equivalent.

Total Cost: \$ 3200.00
