Access Compliance Report Public Rights-of-Way (Curb Ramps)

Intersection ID: 42985 Main St	Cross Street: CHOWNING_TAVERN_LN					Location:	Е	
								0.75
Codes/Mitigation Info/Possible Solution		Field Measurements/Component Compliance						
	Possible Solutions:	<u>c</u>	Compliance Description			Data Compliance Description		
	Remove & Replace Curb Ramp V	Vith N	I/A	Ramp Length (in)	48.0	Yes	Ramp Slope (%)	6.1
	Two New Directional Ramps or Equivalent.	Ν	lo	Ramp Width (in)	38.0	Yes	Ramp XSlope (%)	0.7
		N	I/A	Flare Type LT	N/A	N/A	Flare Type RT	N/A
		Ν	I/A	Flare Slope LT (%)	N/A	N/A	Flare Slope RT (%)	N/A
		Ν	I/A	Flare Traversable LT?	N/A	N/A	Flare Traversable RT?	N/A
		Ν	I/A	Landing Length (in)	N/A	N/A	DWS Provided?	N/A
	Surveyor Notes:	Ν	I/A	Landing Width (in)	N/A	N/A	DWS Contrast?	N/A
	N/A	Ν	I/A	Landing Slope (%)	N/A	N/A	DWS Length (in)	N/A
		Ν	I/A	Landing X Slope (%)	N/A	N/A	DWS Full Width?	N/A
		Ν	I/A	Landing Curb? (Y/N)	N/A	N/A	DWS Offset (in)	N/A
		Ν	I/A	Shared Landing?	N/A

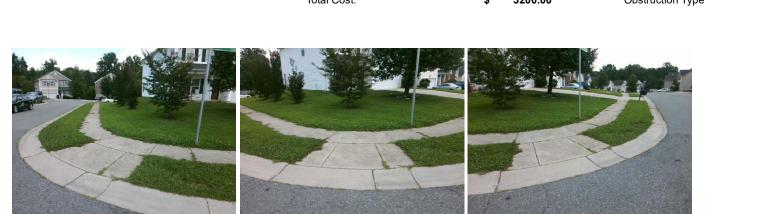
PROW/ADA:	Ν	I/A	Gutter Ponding?	N/A	N/A	Gutter Slope (%)	N/A
	Not Found, R304.5.1	Ν	I/A	Gutter Lip Ht (in)	N/A	N/A	Gutter X Slope (%)	N/A
	,	Ν	I/A	Painted X Walk1?	No	N/A	Painted X Walk2?	No
				X Walk 1 Direction	To NW		X Walk 2 Direction	To SW
	4	Ν	I/A	X Walk 1 Width (in)	N/A	N/A	X Walk 2 Width (in)	N/A
Street 1 Name BESSANT CT	-			X Walk 1 Slope (%)	1.9		X Walk 2 Slope (%)	1.9
Stop Condition-Street 2 StopSign				X Walk 1 X Slope (%)	2.4		X Walk 2 X Slope (%)	2.6
Street 2 Name CHOWNING TAVERN LN		Ν	I/A	Ramp inside XWalk1?	N/A	N/A	Ramp inside XWalk2?	N/A
Stop Condition-Street 1 None				' Road Slope (%)	0.0	N/A	Clear Space?	N/A
				Road X Slope (%)		N/A	Clear Space to XWalk (in)	N/A
		Ν	N/A	Any Obstructions?	N/A	N/A	Storm Grate/Utility Hazard?	N/A
	Total Cost: \$ 3	200.00		Obstruction Type			Storm Grate/Utility Type
