# Access Compliance Report

## Public Rights-of-Way

### (Curb Ramps)

| Intersection ID: 31447 | Main Street: RIDING_HILL_AV | Cross Street: GLENLUCE_AV | Location: SW |

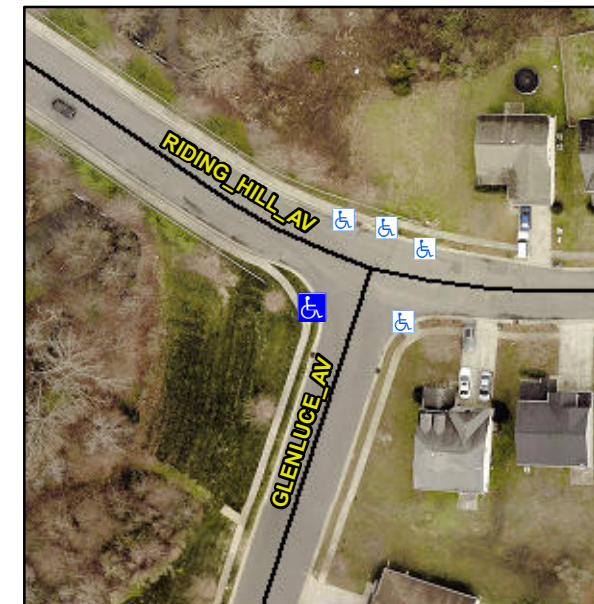
| ADA ID: FC8F5EEA2286 | Ramp Type: BlendTrans1 | Initial Pass/Fail: Fail | Overall Compliance: No |

**Not Found, R304.5.1, R304.5.3**

| Compliance | Description | Data | Compliance | Description | Data |
|---|---|---|---|---|---|
| No | Ramp Width (in) | 47.0 | No | BlendTrans XSlope (%) | 9.4 |

**Remove & Replace Curb Ramp With Two New Directional Ramps or Equivalent.**

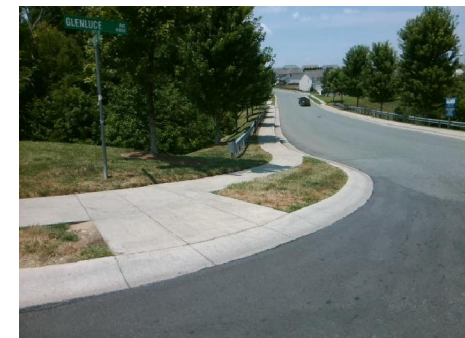
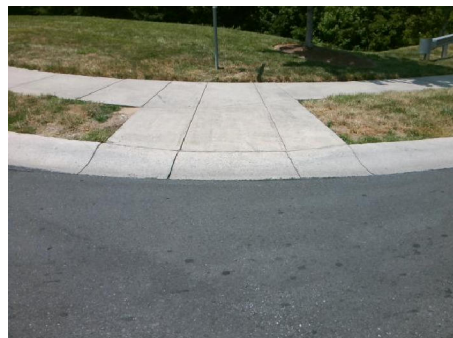
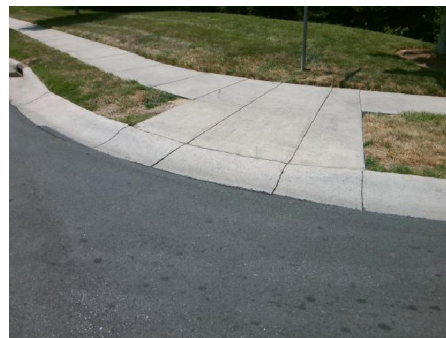
Street 1 Name GLENLUCE AV  
 Stop Condition-Street 1 StopSign  
 Street 2 Name RIDING HILL AV  
 Stop Condition-Street 2 None
